Access Compliance Report

Public Rights-of-Way

(Curb Ramps)

Intersection ID: 13994	Main Street: E_3RD_ST	Cross Street: S_TORRENCE_ST	Location: E
ADA ID: ADF69D3636A6	Ramp Type: Perp	Initial Pass/Fail: Fail	Overall Compliance: No
Severity Score: 10			
Codes/Mitigation Info/Possible Solution		Field Measurements/Component Compliance

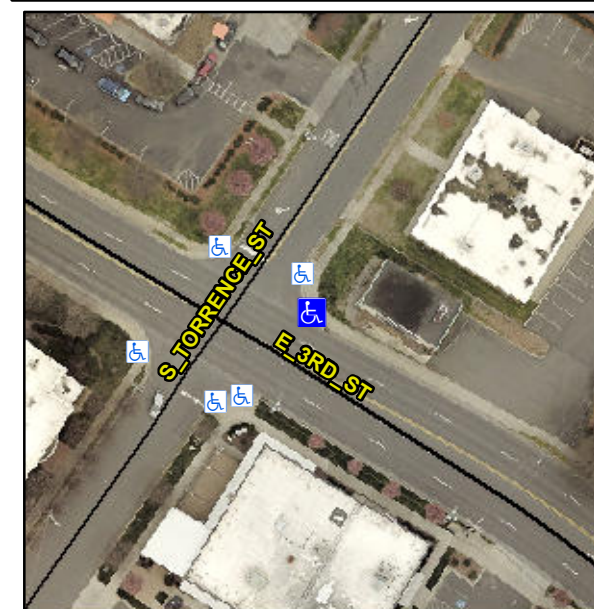
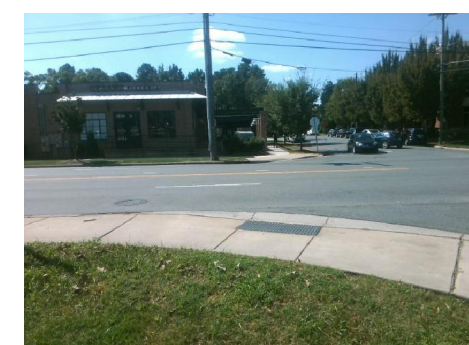
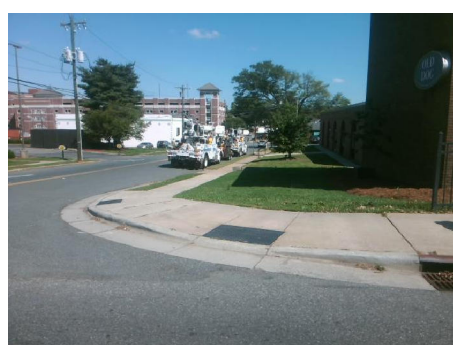
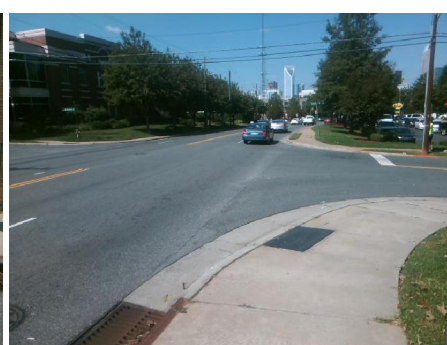
Not Found, R304.5.1, R304.5.3

Compliance	Description	Data	Compliance	Description	Data
N/A	Ramp Length (in)	71.0	Yes	Ramp Slope (%)	5.3
No	Ramp Width (in)	36.0	No	Ramp XSlope (%)	4.3
N/A	Flare Type LT	N/A	N/A	Flare Type RT	N/A
N/A	Flare Slope LT (%)	N/A	N/A	Flare Slope RT (%)	N/A
N/A	Flare Traversable LT?	N/A	N/A	Flare Traversable RT?	N/A
N/A	Landing Length (in)	N/A	N/A	DWS Provided?	N/A
N/A	Landing Width (in)	N/A	N/A	DWS Contrast?	N/A
N/A	Landing Slope (%)	N/A	N/A	DWS Length (in)	N/A
N/A	Landing X Slope (%)	N/A	N/A	DWS Full Width?	N/A
N/A	Landing Curb? (Y/N)	N/A	N/A	DWS Offset (in)	N/A
N/A	Shared Landing?	N/A			
N/A	Gutter Ponding?	N/A	N/A	Gutter Slope (%)	N/A
N/A	Gutter Lip Ht (in)	N/A	N/A	Gutter X Slope (%)	N/A
N/A	Painted X Walk1?	No	N/A	Painted X Walk2?	N/A
	X Walk 1 Direction	To SW		X Walk 2 Direction	N/A
N/A	X Walk 1 Width (in)	N/A	N/A	X Walk 2 Width (in)	N/A
	X Walk 1 Slope (%)	2.3		X Walk 2 Slope (%)	N/A
	X Walk 1 X Slope (%)	2.9		X Walk 2 X Slope (%)	N/A

N/A	Ramp inside XWalk1?	N/A	N/A	Ramp inside XWalk2?	N/A
	Road Slope (%)	N/A	N/A	Clear Space?	N/A
	Road X Slope (%)	N/A	N/A	Clear Space to XWalk (in)	N/A
N/A	Any Obstructions?	N/A	N/A	Storm Grate/Utility Hazard?	N/A
	Obstruction Type			Storm Grate/Utility Type	
		N/A			N/A
			Yes	Surface Condition? (G/P)	Good

Possible Solutions:

Remove & Replace Entire Ramp.
