Access Compliance Report

Public Rights-of-Way

(Curb Ramps)

Intersection ID: 50729	Main Street: TODDINGTON_LN	Cross Street: ALDERGROVE_RD	Location:	N
ADA ID: ADFDEDF3BA95	Ramp Type: PerpDiag	Initial Pass/Fail: Fail	Overall Compliance: No	Severity Score: 8.75

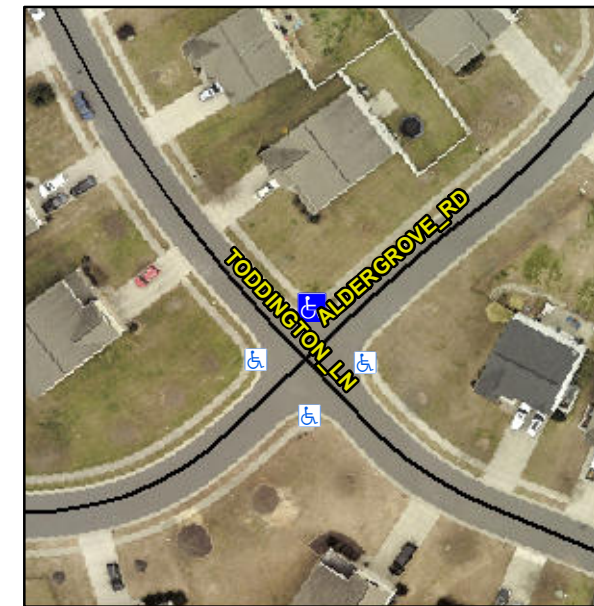
Compliance	Description	Data	Compliance	Description	Data
N/A	Ramp Length (in)	48.5	Yes	Ramp Slope (%)	7.4
No	Ramp Width (in)	47.0	Yes	Ramp XSlope (%)	1.2
N/A	Flare Type LT	N/A	N/A	Flare Type RT	N/A
N/A	Flare Slope LT (%)	N/A	N/A	Flare Slope RT (%)	N/A
N/A	Flare Traversable LT?	N/A	N/A	Flare Traversable RT?	N/A
N/A	Landing Length (in)	N/A	N/A	DWS Provided?	N/A
N/A	Landing Width (in)	N/A	N/A	DWS Contrast?	N/A
N/A	Landing Slope (%)	N/A	N/A	DWS Length (in)	N/A
N/A	Landing X Slope (%)	N/A	N/A	DWS Full Width?	N/A
N/A	Landing Curb? (Y/N)	N/A	N/A	DWS Offset (in)	N/A
N/A	Shared Landing?	N/A			
N/A	Gutter Ponding?	N/A	N/A	Gutter Slope (%)	N/A
N/A	Gutter Lip Ht (in)	N/A	N/A	Gutter X Slope (%)	N/A
N/A	Painted X Walk1?	No	N/A	Painted X Walk2?	No
	X Walk 1 Direction	To SW		X Walk 2 Direction	To SE
N/A	X Walk 1 Width (in)	N/A	N/A	X Walk 2 Width (in)	N/A
	X Walk 1 Slope (%)	1.7		X Walk 2 Slope (%)	3.3
	X Walk 1 X Slope (%)	3.3		X Walk 2 X Slope (%)	2.4

N/A	Ramp inside XWalk1?	N/A	N/A	Ramp inside XWalk2?	N/A
	Road Slope (%)	1.1	N/A	Clear Space?	N/A
	Road X Slope (%)	3.4	N/A	Clear Space to XWalk (in)	N/A
N/A	Any Obstructions?	N/A	N/A	Storm Grate/Utility Hazard?	N/A
	Obstruction Type			Storm Grate/Utility Type	
		N/A			N/A
			Yes	Surface Condition? (G/P)	Good

Remove & Replace Curb Ramp With Two New Directional Ramps or Equivalent.
