Intersection ID: 12493	Main Street: BELVEDERE_AV	Cross Street: WINTER_ST	Location:	SE
ADA ID: AE0540E48EF5	Ramp Type: Perp	Initial Pass/Fail: Fail	Overall Compliance: No	Severity Score: 10

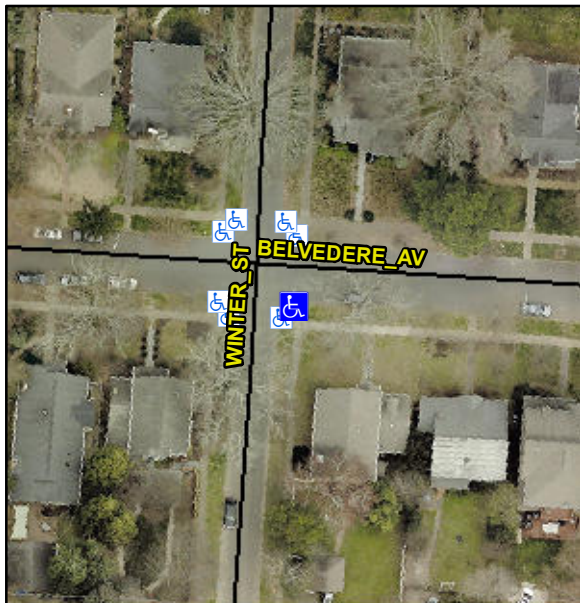
Possible Solutions:		Remove & Replace Entire Ramp.																	
	Surveyor Notes:		N/A																	
	PROW/ADA:		R304.5.1																	
	Street 1 Name		BELVEDERE AV																	
	Stop Condition-Street 2		None																	
	Street 2 Name		N/A																	
	Stop Condition-Street 1		N/A																	
	Total Cost:		\$ 1850.00																	
			Compliance			Description			Data			Compliance			Description			Data		
			N/A			Ramp Length (in)			102.5			Yes			Ramp Slope (%)			5.2		
			No			Ramp Width (in)			45.0			Yes			Ramp XSlope (%)			2.8		
			N/A			Flare Type LT			N/A			N/A			Flare Type RT			N/A		
			N/A			Flare Slope LT (%)			N/A			N/A			Flare Slope RT (%)			N/A		
			N/A			Flare Traversable LT?			N/A			N/A			Flare Traversable RT?			N/A		
			N/A			Landing Length (in)			N/A			N/A			DWS Provided?			N/A

N/A			Landing Width (in)			N/A			N/A			DWS Contrast?			N/A		
			N/A			Landing Slope (%)			N/A			N/A			DWS Length (in)			N/A		
			N/A			Landing X Slope (%)			N/A			N/A			DWS Full Width?			N/A		
			N/A			Landing Curb? (Y/N)			N/A			N/A			DWS Offset (in)			N/A		
			N/A			Shared Landing?			N/A											
			N/A			Gutter Ponding?			Yes			N/A			Gutter Slope (%)			N/A		
			N/A			Gutter Lip Ht (in)			N/A			N/A			Gutter X Slope (%)			N/A		
			N/A			Painted X Walk1?			No			N/A			Painted X Walk2?			N/A		
						X Walk 1 Direction			To N						X Walk 2 Direction			N/A		
			N/A			X Walk 1 Width (in)			N/A			N/A			X Walk 2 Width (in)			N/A		
						X Walk 1 Slope (%)			4.1						X Walk 2 Slope (%)			N/A		
						X Walk 1 X Slope (%)			4.2						X Walk 2 X Slope (%)			N/A		
			N/A			Ramp inside XWalk1?			N/A			N/A			Ramp inside XWalk2?			N/A		
						Road Slope (%)			N/A			N/A			Clear Space?			N/A		
						Road X Slope (%)			N/A			N/A			Clear Space to XWalk (in)			N/A

N/A			Any Obstructions?			N/A			N/A			Storm Grate/Utility Hazard?			N/A		
						Obstruction Type									Storm Grate/Utility Type					
									N/A									N/A		
												Yes			Surface Condition? (G/P)			Good
