# Access Compliance Report

## Public Rights-of-Way

### (Curb Ramps)

| Intersection ID: 14880 | Main Street: ALBEMARLE_RD | Cross Street: KINGHURST_DR | Location: NE |

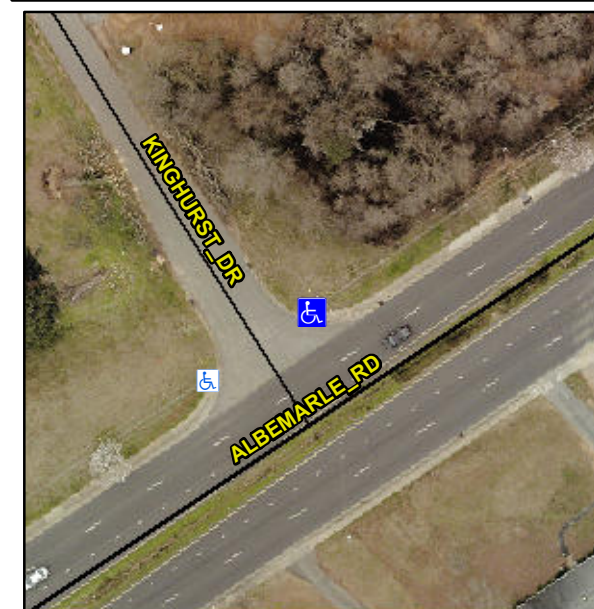
| ADA ID: AE0F169CC67D | Ramp Type: Perp | Initial Pass/Fail: Fail | Overall Compliance: No |
| Severity Score: 12.5 | | | |

**Not Found, R304.2.2**

| Compliance | Description | Data | Compliance | Description | Data |
|---|---|---|---|---|---|
| N/A | Ramp Length (in) | 60.0 | No | Ramp Slope (%) | 8.6 |
| Yes | Ramp Width (in) | 48.0 | Yes | Ramp XSlope (%) | 1.0 |

**Remove & Replace Entire Ramp.**

Total Cost: \$ 1850.00
