# Access Compliance Report

## Public Rights-of-Way

### (Curb Ramps)

Intersection ID: 10917	Main Street: E_25TH_ST	Cross Street: N_DAVIDSON_ST	Location: N
ADA ID: AE140ABFD0AB	Ramp Type: BlendTrans1	Initial Pass/Fail: Fail	Overall Compliance: No
Severity Score: 10			
Codes/Mitigation Info/Possible Solution		Field Measurements/Component Compliance

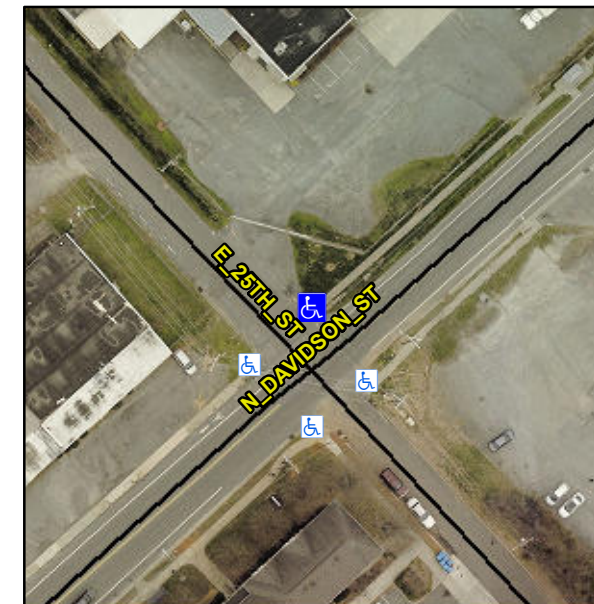
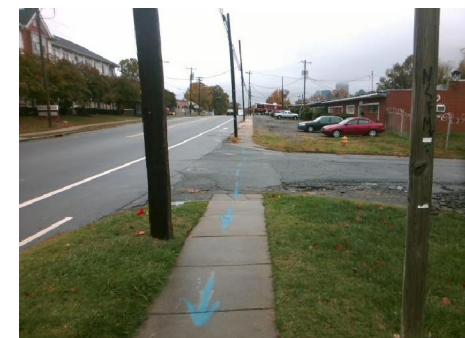
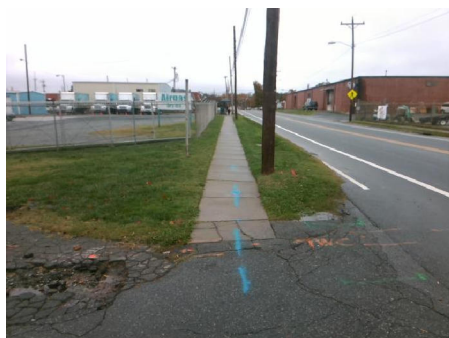
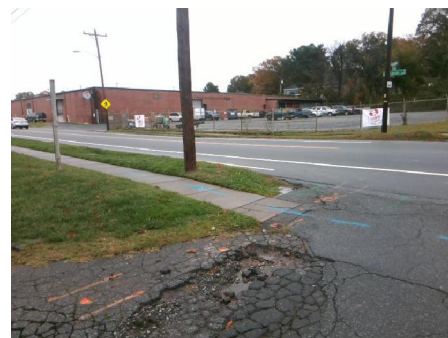
Surveyor Notes:

**RP < 5%, NO CURB**

Compliance	Description	Data	Compliance	Description	Data
N/A	Ramp Length (in)	132.0	Yes	BlendTrans Slope (%)	3.4
No	Ramp Width (in)	47.5	No	BlendTrans XSlope (%)	3.0
N/A	Flare Type LT	N/A	N/A	Flare Type RT	N/A
N/A	Flare Slope LT (%)	N/A	N/A	Flare Slope RT (%)	N/A
N/A	Flare Traversable LT?	N/A	N/A	Flare Traversable RT?	N/A
N/A	Landing Length (in)	N/A	N/A	DWS Provided?	N/A
N/A	Landing Width (in)	N/A	N/A	DWS Contrast?	N/A
N/A	Landing Slope (%)	N/A	N/A	DWS Length (in)	N/A
N/A	Landing X Slope (%)	N/A	N/A	DWS Full Width?	N/A
N/A	Landing Curb? (Y/N)	N/A	N/A	DWS Offset (in)	N/A
N/A	Shared Landing?	N/A			
N/A	Gutter Ponding?	N/A	N/A	Gutter Slope (%)	N/A
N/A	Gutter Lip Ht (in)	N/A	N/A	Gutter X Slope (%)	N/A
N/A	Painted X Walk1?	No	N/A	Painted X Walk2?	N/A
	X Walk 1 Direction	To SW		X Walk 2 Direction	N/A
	X Walk 1 Width (in)	N/A		X Walk 2 Width (in)	N/A
	X Walk 1 Slope (%)	3.3		X Walk 2 Slope (%)	N/A
	X Walk 1 X Slope (%)	6.8		X Walk 2 X Slope (%)	N/A

N/A	Ramp inside XWalk1?	N/A	N/A	Ramp inside XWalk2?	N/A
	Road Slope (%)	6.8		Clear Space?	N/A
	Road X Slope (%)	3.3	N/A	Clear Space to XWalk (in)	N/A
N/A	Any Obstructions?	N/A	N/A	Storm Grate/Utility Hazard?	N/A
	Obstruction Type			Storm Grate/Utility Type	
		N/A			N/A
			Yes	Surface Condition? (G/P)	Good
			N/A	Curb Slope (%)	N/A

Possible Solutions:

**Remove & Replace Curb Ramp With Two New Directional Ramps or Equivalent.**

PROW/ADA:

**R304.5.1, R304.5.3**
