Access Compliance Report

Public Rights-of-Way

(Curb Ramps)

Intersection ID: 11671	Main Street: PARKWOOD_AV	Cross Street: N_CALDWELL_ST	Location: S
ADA ID: AE17FF45D67F	Ramp Type: Perp	Initial Pass/Fail: Fail	Overall Compliance: No
		Severity Score: 12.5

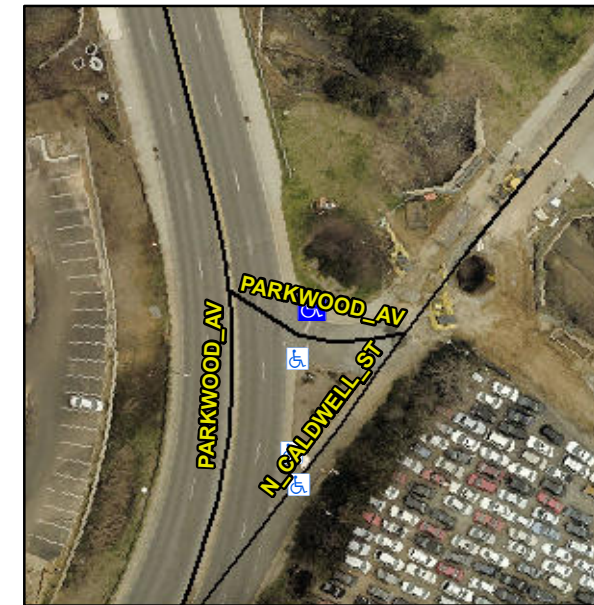
Not Found, R304.2.2

Compliance	Description	Data	Compliance	Description	Data
N/A	Ramp Length (in)	60.0	No	Ramp Slope (%)	9.0
Yes	Ramp Width (in)	51.0	Yes	Ramp XSlope (%)	1.3
N/A	Flare Type LT	N/A	N/A	Flare Type RT	N/A
N/A	Flare Slope LT (%)	N/A	N/A	Flare Slope RT (%)	N/A
N/A	Flare Traversable LT?	N/A	N/A	Flare Traversable RT?	N/A
N/A	Landing Length (in)	N/A	N/A	DWS Provided?	N/A
N/A	Landing Width (in)	N/A	N/A	DWS Contrast?	N/A
N/A	Landing Slope (%)	N/A	N/A	DWS Length (in)	N/A
N/A	Landing X Slope (%)	N/A	N/A	DWS Full Width?	N/A
N/A	Landing Curb? (Y/N)	N/A	N/A	DWS Offset (in)	N/A
N/A	Shared Landing?	N/A			
N/A	Gutter Ponding?	N/A	N/A	Gutter Slope (%)	N/A
N/A	Gutter Lip Ht (in)	N/A	N/A	Gutter X Slope (%)	N/A
N/A	Painted X Walk1?	No	N/A	Painted X Walk2?	N/A
	X Walk 1 Direction	To S		X Walk 2 Direction	N/A
N/A	X Walk 1 Width (in)	N/A	N/A	X Walk 2 Width (in)	N/A
	X Walk 1 Slope (%)	3.8		X Walk 2 Slope (%)	N/A
	X Walk 1 X Slope (%)	0.3		X Walk 2 X Slope (%)	N/A

N/A	Ramp inside XWalk1?	N/A	N/A	Ramp inside XWalk2?	N/A
	Road Slope (%)	N/A	N/A	Clear Space?	N/A
	Road X Slope (%)	N/A	N/A	Clear Space to XWalk (in)	N/A
N/A	Any Obstructions?	N/A	N/A	Storm Grate/Utility Hazard?	N/A
	Obstruction Type			Storm Grate/Utility Type	
		N/A			N/A
			Yes	Surface Condition? (G/P)	Good

Remove & Replace Entire Ramp.

Total Cost: \$ 1850.00
