# Access Compliance Report

## Public Rights-of-Way

### (Curb Ramps)

Intersection ID: 23217	Main Street: GLENEAGLES_RD	Cross Street: QUAIL_HOLLOW_RD	Location: SW
ADA ID: AE2C6524D033	Ramp Type: PerpDiag	Initial Pass/Fail: Fail	Overall Compliance: No
		Severity Score: 26.25

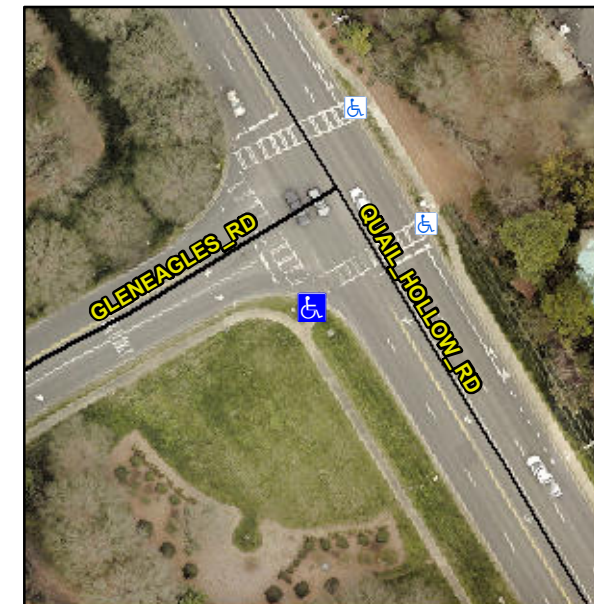
Compliance	Description	Data	Compliance	Description	Data
N/A	Ramp Length (in)	45.0	No	Ramp Slope (%)	12.3
Yes	Ramp Width (in)	48.0	No	Ramp XSlope (%)	2.6
N/A	Flare Type LT	N/A	N/A	Flare Type RT	N/A
N/A	Flare Slope LT (%)	N/A	N/A	Flare Slope RT (%)	N/A
N/A	Flare Traversable LT?	N/A	N/A	Flare Traversable RT?	N/A
N/A	Landing Length (in)	N/A	N/A	DWS Provided?	N/A
N/A	Landing Width (in)	N/A	N/A	DWS Contrast?	N/A
N/A	Landing Slope (%)	N/A	N/A	DWS Length (in)	N/A
N/A	Landing X Slope (%)	N/A	N/A	DWS Full Width?	N/A
N/A	Landing Curb? (Y/N)	N/A	N/A	DWS Offset (in)	N/A
N/A	Shared Landing?	N/A			
N/A	Gutter Ponding?	N/A	N/A	Gutter Slope (%)	N/A
N/A	Gutter Lip Ht (in)	N/A	N/A	Gutter X Slope (%)	N/A
N/A	Painted X Walk1?	Yes	N/A	Painted X Walk2?	Yes
	X Walk 1 Direction	To E		X Walk 2 Direction	To N
N/A	X Walk 1 Width (in)	109.0	N/A	X Walk 2 Width (in)	112.0
	X Walk 1 Slope (%)	2.1		X Walk 2 Slope (%)	2.1
	X Walk 1 X Slope (%)	3.3		X Walk 2 X Slope (%)	2.3

N/A	Ramp inside XWalk1?	Yes	N/A	Ramp inside XWalk2?	Yes
	Road Slope (%)	0.8	N/A	Clear Space?	N/A
	Road X Slope (%)	0.3	N/A	Clear Space to XWalk (in)	N/A
N/A	Any Obstructions?	N/A	N/A	Storm Grate/Utility Hazard?	N/A
	Obstruction Type			Storm Grate/Utility Type	
		N/A			N/A
		Yes		Surface Condition? (G/P)	Good

**Remove & Replace Curb Ramp With Two New Directional Ramps or Equivalent.**

**R304.2.2, R304.5.3**
