Access Compliance Report

Public Rights-of-Way

(Curb Ramps)

Intersection ID: 45504	Main Street: FIRST_BLOOM_RD	Cross Street: MEADOW_BOTTOM_RD	Location: N
ADA ID: AE3EC15F1893	Ramp Type: PerpDiag	Initial Pass/Fail: Fail	Overall Compliance: No
			Severity Score: 33.75

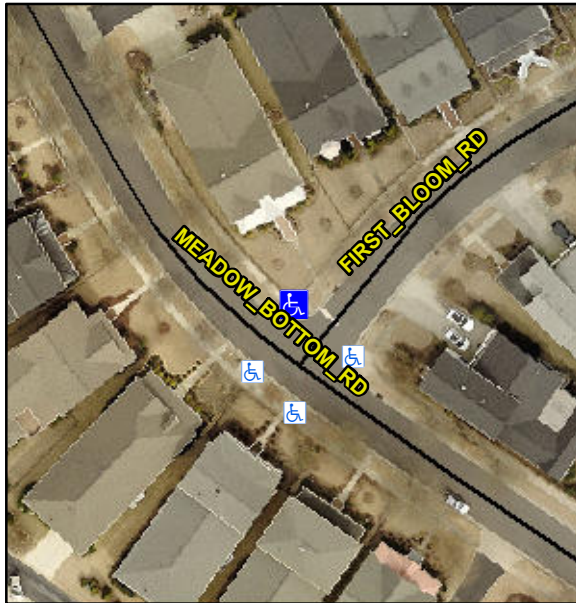
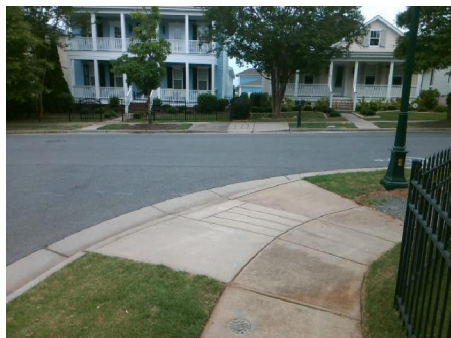
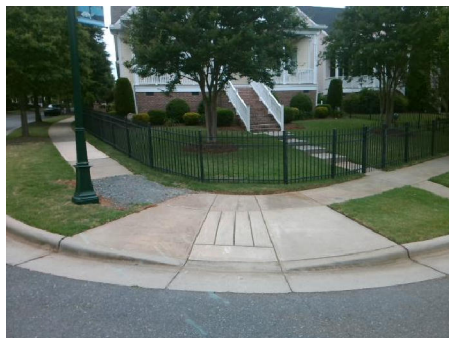
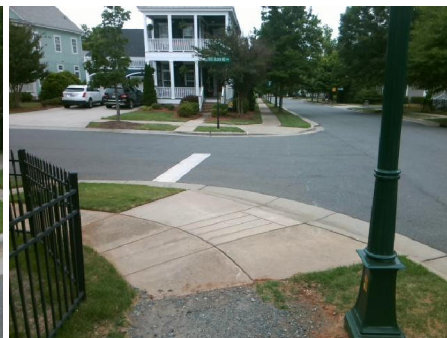
Not Found, R304.5.1, R304.2.2, R304.5.3

Compliance	Description	Data	Compliance	Description	Data
N/A	Ramp Length (in)	71.0	No	Ramp Slope (%)	9.9
No	Ramp Width (in)	36.0	No	Ramp XSlope (%)	5.3
N/A	Flare Type LT	N/A	N/A	Flare Type RT	N/A
N/A	Flare Slope LT (%)	N/A	N/A	Flare Slope RT (%)	N/A
N/A	Flare Traversable LT?	N/A	N/A	Flare Traversable RT?	N/A
N/A	Landing Length (in)	N/A	N/A	DWS Provided?	N/A
N/A	Landing Width (in)	N/A	N/A	DWS Contrast?	N/A
N/A	Landing Slope (%)	N/A	N/A	DWS Length (in)	N/A
N/A	Landing X Slope (%)	N/A	N/A	DWS Full Width?	N/A
N/A	Landing Curb? (Y/N)	N/A	N/A	DWS Offset (in)	N/A
N/A	Shared Landing?	N/A			
N/A	Gutter Ponding?	N/A	N/A	Gutter Slope (%)	N/A
N/A	Gutter Lip Ht (in)	N/A	N/A	Gutter X Slope (%)	N/A
N/A	Painted X Walk1?	No	N/A	Painted X Walk2?	No
	X Walk 1 Direction	To SW		X Walk 2 Direction	To SE
N/A	X Walk 1 Width (in)	N/A	N/A	X Walk 2 Width (in)	N/A
	X Walk 1 Slope (%)	3.4		X Walk 2 Slope (%)	0.5
	X Walk 1 X Slope (%)	1.9		X Walk 2 X Slope (%)	3.7

N/A	Ramp inside XWalk1?	N/A	N/A	Ramp inside XWalk2?	N/A
	Road Slope (%)	5.8	N/A	Clear Space?	N/A
	Road X Slope (%)	2.6	N/A	Clear Space to XWalk (in)	N/A
N/A	Any Obstructions?	N/A	N/A	Storm Grate/Utility Hazard?	N/A
	Obstruction Type			Storm Grate/Utility Type	
		N/A			N/A
			Yes	Surface Condition? (G/P)	Good

Remove & Replace Curb Ramp With Two New Directional Ramps or Equivalent.
