Access Compliance Report

Public Rights-of-Way

(Curb Ramps)

Intersection ID: 10996	Main Street: E_24TH_ST	Cross Street: N_DAVIDSON_ST	Location: S
ADA ID: AE44A8666577	Ramp Type: Perp	Initial Pass/Fail: Fail	Overall Compliance: No
Severity Score: 25			
Codes/Mitigation Info/Possible Solution		Field Measurements/Component Compliance

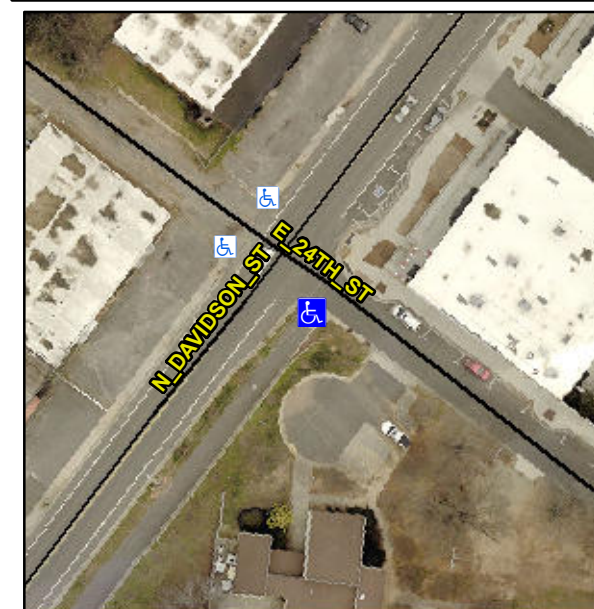
Not Found, R304.5.3

Compliance	Description	Data	Compliance	Description	Data
N/A	Ramp Length (in)	115.5	Yes	Ramp Slope (%)	6.2
Yes	Ramp Width (in)	120.0	No	Ramp XSlope (%)	13.3
N/A	Flare Type LT	N/A	N/A	Flare Type RT	N/A
N/A	Flare Slope LT (%)	N/A	N/A	Flare Slope RT (%)	N/A
N/A	Flare Traversable LT?	N/A	N/A	Flare Traversable RT?	N/A
N/A	Landing Length (in)	N/A	N/A	DWS Provided?	N/A
N/A	Landing Width (in)	N/A	N/A	DWS Contrast?	N/A
N/A	Landing Slope (%)	N/A	N/A	DWS Length (in)	N/A
N/A	Landing X Slope (%)	N/A	N/A	DWS Full Width?	N/A
N/A	Landing Curb? (Y/N)	N/A	N/A	DWS Offset (in)	N/A
N/A	Shared Landing?	N/A			
N/A	Gutter Ponding?	N/A	N/A	Gutter Slope (%)	N/A
N/A	Gutter Lip Ht (in)	N/A	N/A	Gutter X Slope (%)	N/A
N/A	Painted X Walk1?	No	N/A	Painted X Walk2?	N/A
	X Walk 1 Direction	To E		X Walk 2 Direction	N/A
N/A	X Walk 1 Width (in)	N/A	N/A	X Walk 2 Width (in)	N/A
	X Walk 1 Slope (%)	3.9		X Walk 2 Slope (%)	N/A
	X Walk 1 X Slope (%)	10.4		X Walk 2 X Slope (%)	N/A

N/A	Ramp inside XWalk1?	N/A	N/A	Ramp inside XWalk2?	N/A
	Road Slope (%)	N/A	N/A	Clear Space?	N/A
	Road X Slope (%)	N/A	N/A	Clear Space to XWalk (in)	N/A
N/A	Any Obstructions?	N/A	N/A	Storm Grate/Utility Hazard?	N/A
	Obstruction Type			Storm Grate/Utility Type	
		N/A			N/A
		Yes		Surface Condition? (G/P)	Good

Possible Solutions:

Remove & Replace Entire Ramp.
