Intersection ID: 42367 Main Street: FALCONCREST_DR Cross Street: KESTRAL_RIDGE_DR Location: E

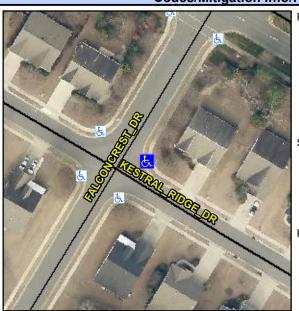
ADA ID: AE483BE2990F Ramp Type: PerpDiag Initial Pass/Fail: Pass Overall Compliance: No Severity Score: 20

PROW/ADA:
Not Found, R304.2.2, R305, R302.7.2

| Comp | liance Description | Data | Comp | liance Description | Data |
|---|---|---|---|---|---|
| N/A | Ramp Length (in) | 46.0 | No | Ramp Slope (%) | 8.4 |
| Yes | Landing Length (in) | 48.0 | No | DWS Provided? | No |
| No | Gutter Lip Ht (in) | 0.5 | Yes | Gutter X Slope (%) | 0.3 |

Remove & Replace Curb Ramp With
Two New Directional Ramps or
Equivalent.

Total Cost: \$ 3200.00
