# Access Compliance Report

## Public Rights-of-Way

### (Curb Ramps)

Intersection ID: 10020376	Main Street: BALLANTYNE CORPORATE PK	Cross Street: N/A	Location:	S
ADA ID: AE4F4D5E778E	Ramp Type: Perp	Initial Pass/Fail: Fail	Overall Compliance: No	Severity Score: 12.5
Codes/Mitigation Info/Possible Solution		Field Measurements/Component Compliance

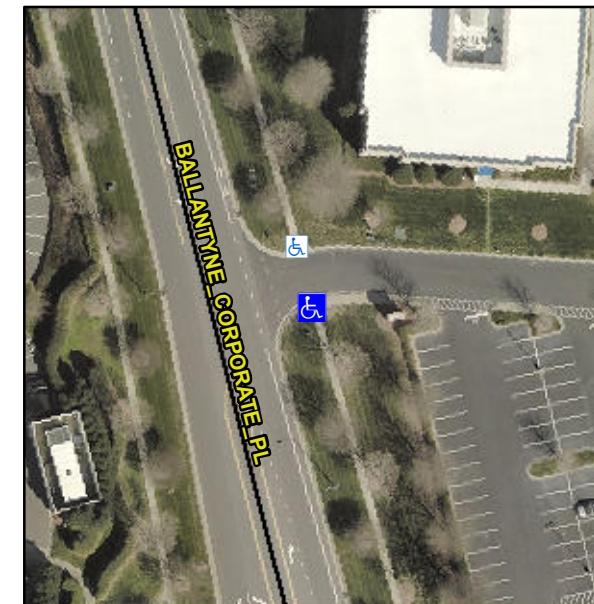
**R304.5.3**

Compliance	Description	Data	Compliance	Description	Data
N/A	Ramp Length (in)	64.0	Yes	Ramp Slope (%)	7.3
Yes	Ramp Width (in)	48.0	No	Ramp XSlope (%)	6.0
N/A	Flare Type LT	N/A	N/A	Flare Type RT	N/A
N/A	Flare Slope LT (%)	N/A	N/A	Flare Slope RT (%)	N/A
N/A	Flare Traversable LT?	N/A	N/A	Flare Traversable RT?	N/A
N/A	Landing Length (in)	N/A	N/A	DWS Provided?	N/A
N/A	Landing Width (in)	N/A	N/A	DWS Contrast?	N/A
N/A	Landing Slope (%)	N/A	N/A	DWS Length (in)	N/A
N/A	Landing X Slope (%)	N/A	N/A	DWS Full Width?	N/A
N/A	Landing Curb? (Y/N)	N/A	N/A	DWS Offset (in)	N/A
N/A	Shared Landing?	N/A			
N/A	Gutter Ponding?	N/A	N/A	Gutter Slope (%)	N/A
N/A	Gutter Lip Ht (in)	N/A	N/A	Gutter X Slope (%)	N/A
N/A	Painted X Walk1?	No	N/A	Painted X Walk2?	N/A
	X Walk 1 Direction	To N		X Walk 2 Direction	N/A
N/A	X Walk 1 Width (in)	N/A	N/A	X Walk 2 Width (in)	N/A
	X Walk 1 Slope (%)	4.2		X Walk 2 Slope (%)	N/A
	X Walk 1 X Slope (%)	4.9		X Walk 2 X Slope (%)	N/A

N/A	Ramp inside XWalk1?	N/A	N/A	Ramp inside XWalk2?	N/A
	Road Slope (%)	N/A	N/A	Clear Space?	N/A
	Road X Slope (%)	N/A	N/A	Clear Space to XWalk (in)	N/A
N/A	Any Obstructions?	N/A	N/A	Storm Grate/Utility Hazard?	N/A
	Obstruction Type			Storm Grate/Utility Type	
		N/A			N/A
			Yes	Surface Condition? (G/P)	Good

**Remove & Replace Entire Ramp.**

\$ 1850.00
