## **Access Compliance Report Public Rights-of-Way** (Curb Ramps)

Intersection ID: 10431 Main Street: ASHLEY RD **Cross Street: SCOTT FUTRELL DR** Location: NW **ADA ID: AE5295B4D87A** Ramp Type: Perp Initial Pass/Fail: Fail **Overall Compliance: No Severity Score:** 12.5

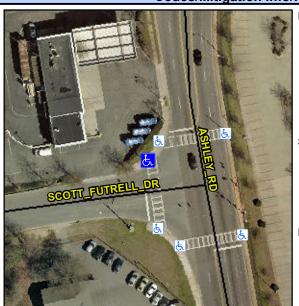
Field Measurements/Component Compliance									
Comp	liance Description	Data	Comp	liance Description	Data				
N/A	Ramp Length (in)	83.5	No	Ramp Slope (%)	9.2				
Yes	Ramp Width (in)	48.0	Yes	Ramp XSlope (%)	0.1				
N/A	Flare Type LT	N/A	N/A	Flare Type RT	N/A				
N/A	Flare Slope LT (%)	N/A	N/A	Flare Slope RT (%)	N/A				
N/A	Flare Traversable LT?	N/A	N/A	Flare Traversable RT?	N/A				
N/A	Landing Length (in)	N/A	N/A	DWS Provided?	N/A				
N/A	Landing Width (in)	N/A	N/A	DWS Contrast?	N/A				
N/A	Landing Slope (%)	N/A	N/A	DWS Length (in)	N/A				
N/A	Landing X Slope (%)	N/A	N/A	DWS Full Width?	N/A				
N/A	Landing Curb? (Y/N)	N/A	N/A	DWS Offset (in)	N/A				
N/A	Shared Landing?	N/A							
N/A	Gutter Ponding?	N/A	N/A	Gutter Slope (%)	N/A				
N/A	Gutter Lip Ht (in)	N/A	N/A	Gutter X Slope (%)	N/A				
N/A	Painted X Walk1?	Yes	N/A	Painted X Walk2?	N/A				
	X Walk 1 Direction	To S		X Walk 2 Direction	N/A				
N/A	X Walk 1 Width (in)	114.0	N/A	X Walk 2 Width (in)	N/A

X Walk 1 Slope (%)	5.0		X Walk 2 Slope (%)	N/A				
	X Walk 1 X Slope (%)	2.7		X Walk 2 X Slope (%)	N/A				
N/A	Ramp inside XWalk1?	Yes	N/A	Ramp inside XWalk2?	N/A				
	Road Slope (%)	N/A	N/A	Clear Space?	N/A				
	Road X Slope (%)	N/A	N/A	Clear Space to XWalk (in)	N/A				
N/A	Any Obstructions?	N/A	N/A	Storm Grate/Utility Hazard?	N/A				
	Obstruction Type			Storm Grate/Utility Type					
		N/A			N/A				
VIII.			Yes	Surface Condition? (G/P)	Good

Possible Solutions:	_							
Remove & Replace Entire Ramp.								
Surveyor Notes:								
N/A								
1071								
PROW/ADA:								
R304.2.2
