Access Compliance Report Public Rights-of-Way (Curb Ramps)

Intersection ID: 3655 Main Street: SHENINGTON PL **Cross Street: TREYBURN DR** Location: NE ADA ID: AE5E75FD126C Ramp Type: Perp Initial Pass/Fail: Fail **Overall Compliance: No Severity Score:** 12.5

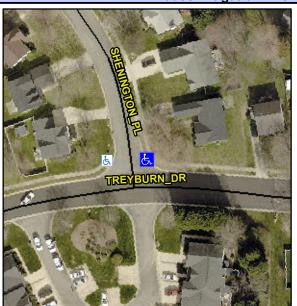
A/A	Ramp Length (in)	48.0	No	Ramp Slope (%)	9.3
⁄es	Ramp Width (in)	48.0	Yes	Ramp XSlope (%)	1.9
N/A	Flare Type LT	N/A	N/A	Flare Type RT	N/A
N/A	Flare Slope LT (%)	N/A	N/A	Flare Slope RT (%)	N/A
N/A	Flare Traversable LT?	N/A	N/A	Flare Traversable RT?	N/A
N/A	Landing Length (in)	N/A	N/A	DWS Provided?	N/A
N/A	Landing Width (in)	N/A	N/A	DWS Contrast?	N/A
N/A	Landing Slope (%)	N/A	N/A	DWS Length (in)	N/A
N/A	Landing X Slope (%)	N/A	N/A	DWS Full Width?	N/A
N/A	Landing Curb? (Y/N)	N/A	N/A	DWS Offset (in)	N/A
N/A	Shared Landing?	N/A			
N/A	Gutter Ponding?	N/A	N/A	Gutter Slope (%)	N/A
N/A	Gutter Lip Ht (in)	N/A	N/A	Gutter X Slope (%)	N/A
N/A	Painted X Walk1?	No	N/A	Painted X Walk2?	N/A
	X Walk 1 Direction	To W		X Walk 2 Direction	N/A
N/A	X Walk 1 Width (in)	N/A	N/A	X Walk 2 Width (in)	N/A
	X Walk 1 Slope (%)	1.2		X Walk 2 Slope (%)	N/A
	X Walk 1 X Slope (%)	3.4		X Walk 2 X Slope (%)	N/A
N/A	Ramp inside XWalk1?	N/A	N/A	Ramp inside XWalk2?	N/A

Possible Solutions:	Compli	ance	Description
Remove & Replace Entire Ramp.	N/A Ramp Length (in)		
	Yes	Ramp Width (in)	
	N/A	Flare Type LT	
	N/A	Flare Slope LT (%)	
	N/A	Flare Traversable LT	
	N/A	Landing Length (in)	
Surveyor Notes:	N/A	Land	ing Width (in)
N/A	N/A	Land	ing Slope (%)
	N/A	Land	ing X Slope (%)
	N/A	Land	ing Curb? (Y/N)
	N/A	Share	ed Landing?
PROW/ADA:	N/A	Gutte	er Ponding?
Not Found, R304.2.2	N/A	Gutte	er Lip Ht (in)
	N/A	Paint	ed X Walk1?
		X Wa	lk 1 Direction
	N/A	X Wa	ılk 1 Width (in)
		V 11/-	II. 4 Class = (0/)
