Access Compliance Report

Public Rights-of-Way

(Curb Ramps)

Intersection ID: 47840	Main Street: PECO_RD	Cross Street: CACTUS_VALLEY_RD	Location: SE
ADA ID: AE6AF81A2845	Ramp Type: Perp	Initial Pass/Fail: Fail	Overall Compliance: No
Severity Score: 21.25			
Codes/Mitigation Info/Possible Solution		Field Measurements/Component Compliance

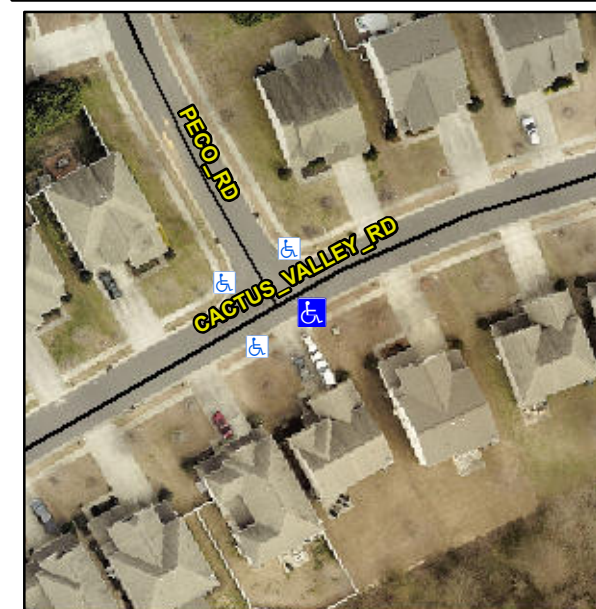
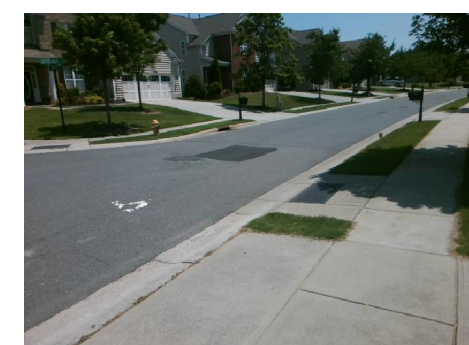
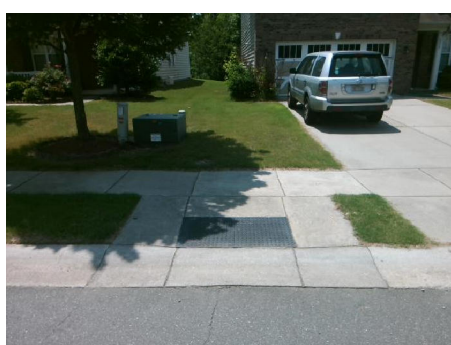
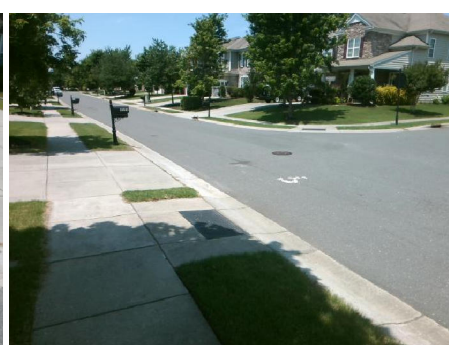
PROW/ADA:

Not Found, R304.5.1, R304.2.2

Compliance	Description	Data	Compliance	Description	Data
N/A	Ramp Length (in)	49.0	No	Ramp Slope (%)	9.2
No	Ramp Width (in)	45.5	Yes	Ramp XSlope (%)	2.0
N/A	Flare Type LT	N/A	N/A	Flare Type RT	N/A
N/A	Flare Slope LT (%)	N/A	N/A	Flare Slope RT (%)	N/A
N/A	Flare Traversable LT?	N/A	N/A	Flare Traversable RT?	N/A
N/A	Landing Length (in)	N/A	N/A	DWS Provided?	N/A
N/A	Landing Width (in)	N/A	N/A	DWS Contrast?	N/A
N/A	Landing Slope (%)	N/A	N/A	DWS Length (in)	N/A
N/A	Landing X Slope (%)	N/A	N/A	DWS Full Width?	N/A
N/A	Landing Curb? (Y/N)	N/A	N/A	DWS Offset (in)	N/A
N/A	Shared Landing?	N/A			
N/A	Gutter Ponding?	N/A	N/A	Gutter Slope (%)	N/A
N/A	Gutter Lip Ht (in)	N/A	N/A	Gutter X Slope (%)	N/A
N/A	Painted X Walk1?	No	N/A	Painted X Walk2?	N/A
	X Walk 1 Direction	To NW		X Walk 2 Direction	N/A
N/A	X Walk 1 Width (in)	N/A	N/A	X Walk 2 Width (in)	N/A
	X Walk 1 Slope (%)	2.9		X Walk 2 Slope (%)	N/A
	X Walk 1 X Slope (%)	1.6		X Walk 2 X Slope (%)	N/A

N/A	Ramp inside XWalk1?	N/A	N/A	Ramp inside XWalk2?	N/A
	Road Slope (%)	N/A	N/A	Clear Space?	N/A
	Road X Slope (%)	N/A	N/A	Clear Space to XWalk (in)	N/A
N/A	Any Obstructions?	N/A	N/A	Storm Grate/Utility Hazard?	N/A
	Obstruction Type			Storm Grate/Utility Type	
		N/A			N/A
			Yes	Surface Condition? (G/P)	Good

Possible Solutions:

Remove & Replace Entire Ramp.
