Access Compliance Report

Public Rights-of-Way

(Curb Ramps)

Intersection ID: 8473	Main Street: BEECHWAY_CR	Cross Street: SPRINGVIEW_RD	Location: SE
ADA ID: AE819071761B	Ramp Type: Perp	Initial Pass/Fail: Fail	Overall Compliance: No
Severity Score: 35			
Codes/Mitigation Info/Possible Solution		Field Measurements/Component Compliance

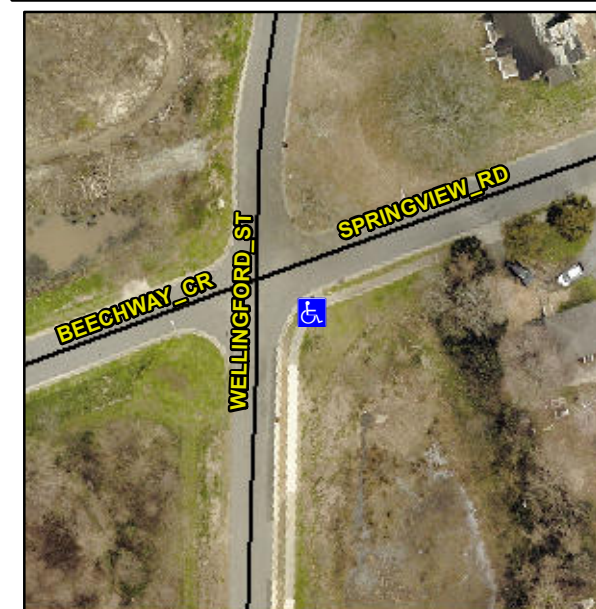
Not Found, R304.5.1, R304.2.2

Compliance	Description	Data	Compliance	Description	Data
N/A	Ramp Length (in)	49.0	No	Ramp Slope (%)	12.7
No	Ramp Width (in)	40.5	Yes	Ramp XSlope (%)	2.4
N/A	Flare Type LT	N/A	N/A	Flare Type RT	N/A
N/A	Flare Slope LT (%)	N/A	N/A	Flare Slope RT (%)	N/A
N/A	Flare Traversable LT?	N/A	N/A	Flare Traversable RT?	N/A
N/A	Landing Length (in)	N/A	N/A	DWS Provided?	N/A
N/A	Landing Width (in)	N/A	N/A	DWS Contrast?	N/A
N/A	Landing Slope (%)	N/A	N/A	DWS Length (in)	N/A
N/A	Landing X Slope (%)	N/A	N/A	DWS Full Width?	N/A
N/A	Landing Curb? (Y/N)	N/A	N/A	DWS Offset (in)	N/A
N/A	Shared Landing?	N/A			
N/A	Gutter Ponding?	N/A	N/A	Gutter Slope (%)	N/A
N/A	Gutter Lip Ht (in)	N/A	N/A	Gutter X Slope (%)	N/A
N/A	Painted X Walk1?	No	N/A	Painted X Walk2?	N/A
	X Walk 1 Direction	To NW		X Walk 2 Direction	N/A
N/A	X Walk 1 Width (in)	N/A	N/A	X Walk 2 Width (in)	N/A
	X Walk 1 Slope (%)	3.8		X Walk 2 Slope (%)	N/A
	X Walk 1 X Slope (%)	2.4		X Walk 2 X Slope (%)	N/A

Remove & Replace Entire Ramp.
