## Access Compliance Report Public Rights-of-Way (Curb Ramps)

/	
Intersection ID: 46820	Main Street: NORWAY_SPRUCE_CT			Cross Street: AZALEA_HILLS_DR				Location:	Ν	
ADA ID: AE8983D0639F	Ramp Type: PerpDiag		Initial	Initial Pass/Fail: Fail Overall Complian			nce: No Severity Score:		47.5	
Codes/Mitigation Info/Possible Solution					Field Measurements/Component Compliance					
		Possible Solutions:		Compliance Description			Data Compliance Description			
		Remove & Replace Curb Ramp	amp With	N/A	Ramp Length (in)	47.5		Ramp Slope (%)	9.5	
human of the		Two New Directional Ramps or Equivalent.		No	Ramp Width (in)	31.0	Yes	Ramp XSlope (%)	0.2	
				N/A	Flare Type LT	N/A	N/A	Flare Type RT	N/A	
				N/A	Flare Slope LT (%)	N/A	N/A	Flare Slope RT (%)	N/A	
10 100				N/A	Flare Traversable LT?	N/A	N/A	Flare Traversable RT?	N/A	
				N/A	Landing Length (in)	N/A	N/A	DWS Provided?	N/A	
		Surveyor Notes:		N/A	Landing Width (in)	N/A	N/A	DWS Contrast?	N/A	
2		N/A		N/A	Landing Slope (%)	N/A	N/A	DWS Length (in)	N/A

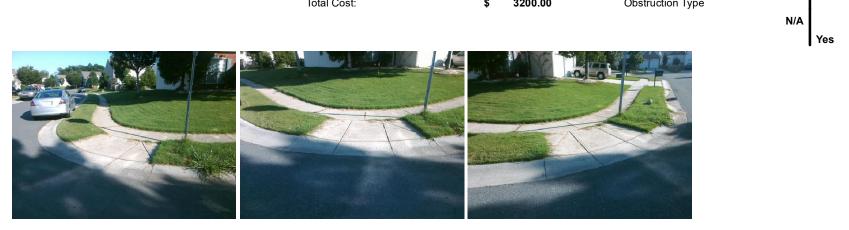
5 Start Kill			N/A	Landing X Slope (%)	N/A	N/A	DWS Full Width?	N/A	
A A A	A LOAD IN			N/A	Landing Curb? (Y/N)	N/A	N/A	DWS Offset (in)	N/A	
Charles a	S. SHILLS DO			N/A	Shared Landing?	N/A				
1 HANKA	1	PROW/ADA:		N/A	Gutter Ponding?	N/A	N/A	Gutter Slope (%)	N/A	
a made of	AND	R304.5.1, R304.2.2		N/A	Gutter Lip Ht (in)	N/A	N/A	Gutter X Slope (%)	N/A	
and we have the	A MAR			N/A	Painted X Walk1?	No	N/A	Painted X Walk2?	No	
A DAMA AND A					X Walk 1 Direction	To SW		X Walk 2 Direction	To SE	
A TRANSFORMENT AND				N/A	X Walk 1 Width (in)	N/A	N/A	X Walk 2 Width (in)	N/A	
Street 1 Name	AZALEA HILLS DR	-			X Walk 1 Slope (%)	3.8		X Walk 2 Slope (%)	0.3	
Stop Condition-Street 2	None				X Walk 1 X Slope (%)	0.4		X Walk 2 X Slope (%)	0.4	
Street 2 Name	NORWAY SPRUCE CT			N/A	Ramp inside XWalk1?	N/A	N/A	Ramp inside XWalk2?	N/A	
Stop Condition-Street 1	StopSign				Road Slope (%)	1.4	N/A	Clear Space?	N/A	
					Road X Slope (%)	0.6	N/A	Clear Space to XWalk (in)	N/A

N/A	Any Obstructions?	N/A	N/A	Storm Grate/Utility Hazard?	N/A	
		Total Cost: \$	3200.00		Obstruction Type			Storm Grate/Utility Type		
						N/A			N/A
