Access Compliance Report Public Rights-of-Way (Curb Ramps)

Intersection ID: 5162 Main Street: BROOKFIELD POINTE DR **Cross Street: SUNSET RD** Location: S ADA ID: AE8CA1550449 Ramp Type: PerpDiag Initial Pass/Fail: Fail **Overall Compliance: No Severity Score:** 10

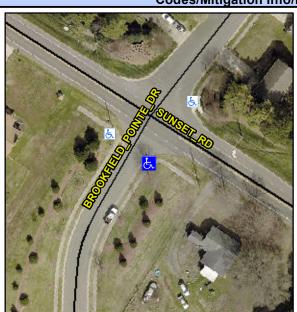
i ieiu ivieasui e	enilenile/C	onipoi	ient compnance	
Compl	Compliance Description		Compliance Description		Data
N/A	Ramp Length (in)	48.5	Yes	Ramp Slope (%)	6.5
No	Ramp Width (in)	41.0	No	Ramp XSlope (%)	3.0
N/A	Flare Type LT	N/A	N/A	Flare Type RT	N/A
N/A	Flare Slope LT (%)	N/A	N/A	Flare Slope RT (%)	N/A
N/A	Flare Traversable LT?	N/A	N/A	Flare Traversable RT?	N/A
N/A	Landing Length (in)	N/A	N/A	DWS Provided?	N/A
N/A	Landing Width (in)	N/A	N/A	DWS Contrast?	N/A
N/A	Landing Slope (%)	N/A	N/A	DWS Length (in)	N/A
N/A	Landing X Slope (%)	N/A	N/A	DWS Full Width?	N/A
N/A	Landing Curb? (Y/N)	N/A	N/A	DWS Offset (in)	N/A
N/A	Shared Landing?	N/A			
N/A	Gutter Ponding?	N/A	N/A	Gutter Slope (%)	N/A
N/A	Gutter Lip Ht (in)	N/A	N/A	Gutter X Slope (%)	N/A
N/A	Painted X Walk1?	No	N/A	Painted X Walk2?	No
	X Walk 1 Direction	To NE		X Walk 2 Direction	To NW
N/A	X Walk 1 Width (in)	N/A	N/A	X Walk 2 Width (in)	N/A
	X Walk 1 Slope (%)	6.9		X Walk 2 Slope (%)	2.5

X Walk 1 X Slope (%)	1.6		X Walk 2 X Slope (%)	4.3
N/A	Ramp inside XWalk1?	N/A	N/A	Ramp inside XWalk2?	N/A
	Road Slope (%)	1.8	N/A	Clear Space?	N/A
	Road X Slope (%)	3.3	N/A	Clear Space to XWalk (in)	N/A
N/A	Any Obstructions?	N/A	N/A	Storm Grate/Utility Hazard?	N/A
	Obstruction Type		l	Storm Grate/Utility Type	
		N/A			N/A

Possible Solutions: Remove & Replace Curb Ramp With Two New Directional Ramps or Equivalent. Surveyor Notes: N/A PROW/ADA: Not Found, R304.5.1, R304.5.3
