Access Compliance Report

Public Rights-of-Way

(Curb Ramps)

Intersection ID: 43133	Main Street: STATESVILLE_AV	Cross Street: CARMINE_ST	Location: SE
ADA ID: AE8EAAF6021C	Ramp Type: Perp	Initial Pass/Fail: Fail	Overall Compliance: No
Codes/Mitigation Info/Possible Solution		Field Measurements/Component Compliance	
Severity Score: 12.5

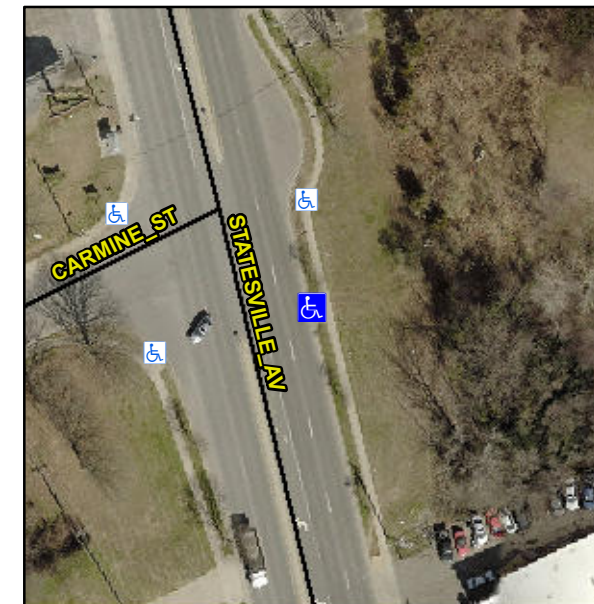
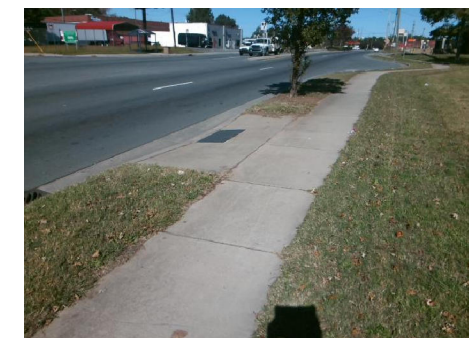
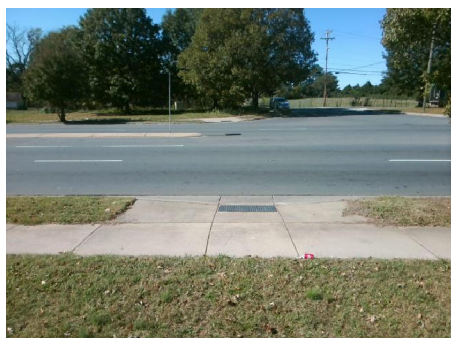
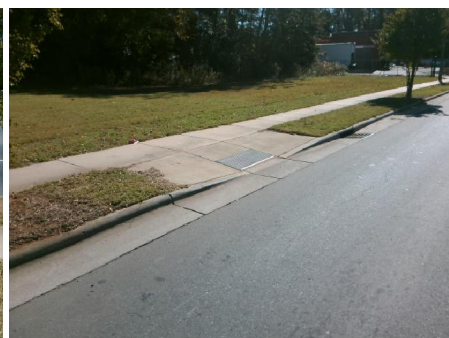
Compliance	Description	Data	Compliance	Description	Data
N/A	Ramp Length (in)	59.0	No	Ramp Slope (%)	11.2
Yes	Ramp Width (in)	48.5	Yes	Ramp XSlope (%)	1.5
N/A	Flare Type LT	N/A	N/A	Flare Type RT	N/A
N/A	Flare Slope LT (%)	N/A	N/A	Flare Slope RT (%)	N/A
N/A	Flare Traversable LT?	N/A	N/A	Flare Traversable RT?	N/A
N/A	Landing Length (in)	N/A	N/A	DWS Provided?	N/A
N/A	Landing Width (in)	N/A	N/A	DWS Contrast?	N/A
N/A	Landing Slope (%)	N/A	N/A	DWS Length (in)	N/A
N/A	Landing X Slope (%)	N/A	N/A	DWS Full Width?	N/A
N/A	Landing Curb? (Y/N)	N/A	N/A	DWS Offset (in)	N/A
N/A	Shared Landing?	N/A			
N/A	Gutter Ponding?	N/A	N/A	Gutter Slope (%)	N/A
N/A	Gutter Lip Ht (in)	N/A	N/A	Gutter X Slope (%)	N/A
N/A	Painted X Walk1?	No	N/A	Painted X Walk2?	N/A
	X Walk 1 Direction	To W		X Walk 2 Direction	N/A
N/A	X Walk 1 Width (in)	N/A	N/A	X Walk 2 Width (in)	N/A
	X Walk 1 Slope (%)	2.6		X Walk 2 Slope (%)	N/A
	X Walk 1 X Slope (%)	2.7		X Walk 2 X Slope (%)	N/A

N/A	Ramp inside XWalk1?	N/A	N/A	Ramp inside XWalk2?	N/A
	Road Slope (%)	N/A	N/A	Clear Space?	N/A
	Road X Slope (%)	N/A	N/A	Clear Space to XWalk (in)	N/A
N/A	Any Obstructions?	N/A	N/A	Storm Grate/Utility Hazard?	N/A
	Obstruction Type			Storm Grate/Utility Type	
		N/A			N/A
			Yes	Surface Condition? (G/P)	Good

Remove & Replace Entire Ramp.
