Access Compliance Report

(Curb Ramps)

Intersection ID: 3285	Main Street: MALLARD_CREEK_RD	Cross Street: JOHNSTON_OEHLER_RD	Location:	S
ADA ID: AEA2204FC109	Ramp Type: Combination1	Initial Pass/Fail: Fail	Overall Compliance: No	Severity Score: 22.5

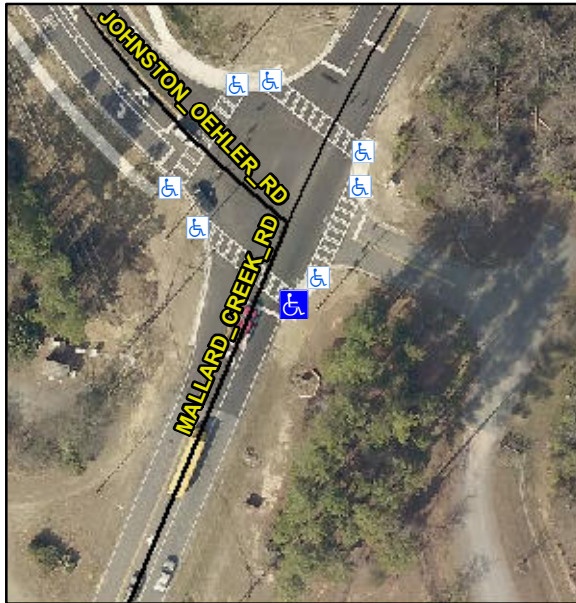
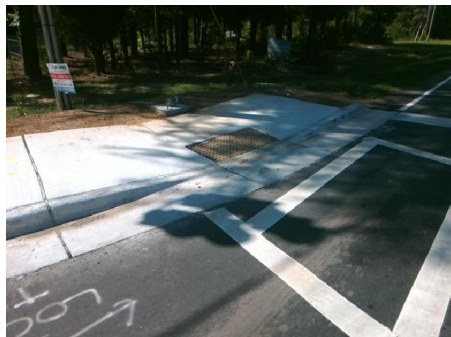
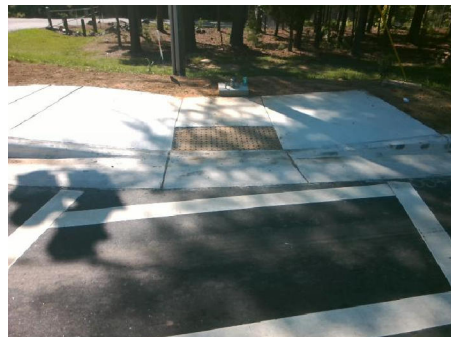
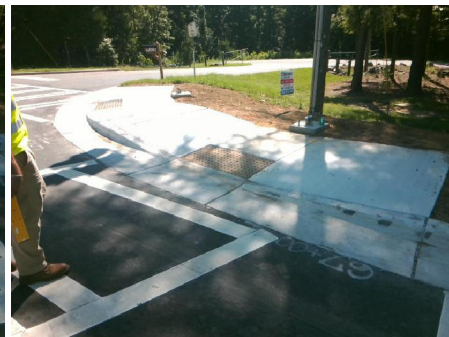
RT RP < 5%

R304.5.1, R304.3.2, R304.5.3

Compliance	Description	Data	Compliance	Description	Data
N/A	Ramp Length LT (in)	58.0	N/A	Ramp Length RT (in)	66.0
No	Ramp Width LT (in)	47.0	Yes	Ramp Width RT (in)	48.0
No	Ramp Slope LT (%)	11.2	Yes	Ramp Slope RT (%)	2.3
No	Ramp XSlope LT (%)	2.1	Yes	Ramp XSlope RT (%)	0.7
N/A	Ramp Length (in)	24.0	Yes	Ramp Slope (%)	6.8
Yes	Ramp Width (in)	48.0	Yes	Ramp XSlope (%)	1.1
N/A	Flare Type LT	N/A	N/A	Flare Type RT	N/A
N/A	Flare Slope LT (%)	N/A	N/A	Flare Slope RT (%)	N/A
N/A	Flare Traversable LT?	N/A	N/A	Flare Traversable RT?	N/A
N/A	Landing Length (in)	N/A	N/A	DWS Provided?	N/A
N/A	Landing Width (in)	N/A	N/A	DWS Contrast?	N/A
N/A	Landing Slope (%)	N/A	N/A	DWS Length (in)	N/A
N/A	Landing X Slope (%)	N/A	N/A	DWS Full Width?	N/A
N/A	Landing Curb? (Y/N)	N/A	N/A	DWS Offset (in)	N/A
N/A	Shared Landing?	N/A			
N/A	Gutter Ponding?	N/A	N/A	Gutter Slope (%)	N/A
N/A	Gutter Lip Ht (in)	N/A	N/A	Gutter X Slope (%)	N/A
N/A	Painted X Walk1?	Yes	N/A	Painted X Walk2?	N/A

X Walk 1 Direction	To NW		X Walk 2 Direction	N/A
	X Walk 1 Width (in)	108.0		X Walk 2 Width (in)	N/A
	X Walk 1 Slope (%)	3.2		X Walk 2 Slope (%)	N/A
	X Walk 1 X Slope (%)	2.3		X Walk 2 X Slope (%)	N/A
N/A	Ramp inside XWalk1?	Yes	N/A	Ramp inside XWalk2?	N/A
	Road Slope (%)	N/A		Clear Space?	N/A
	Road X Slope (%)	N/A	N/A	Clear Space to XWalk (in)	N/A
			N/A	Any Obstruction?	N/A
				Obstruction Type	N/A
			N/A	Storm Grate/Utility Hazard?	N/A
				Storm Grate/Utility Type	N/A
			Yes	Surface Condition? (G/P)	Good
				Curb Slope (%)	N/A

Remove & Replace Entire Ramp.

Total Cost: \$ 1800.00
