Access Compliance Report

Public Rights-of-Way

(Curb Ramps)

Intersection ID: 13553	Main Street: WINGATE_AV	Cross Street: DODGE_AV	Location: SW
ADA ID: AEA93E346BD5	Ramp Type: PerpDiag	Initial Pass/Fail: Fail	Overall Compliance: No
Severity Score: 12.5			
Codes/Mitigation Info/Possible Solution		Field Measurements/Component Compliance

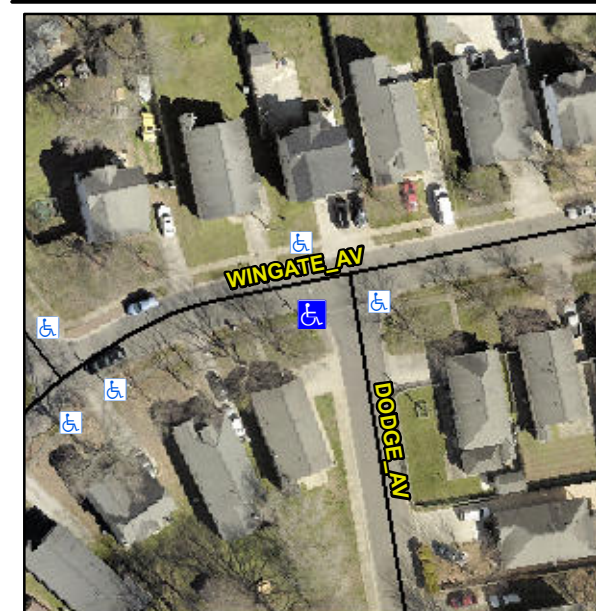
Not Found, R304.2.2

Compliance	Description	Data	Compliance	Description	Data
N/A	Ramp Length (in)	72.0	No	Ramp Slope (%)	9.3
Yes	Ramp Width (in)	48.0	Yes	Ramp XSlope (%)	1.9
N/A	Flare Type LT	N/A	N/A	Flare Type RT	N/A
N/A	Flare Slope LT (%)	N/A	N/A	Flare Slope RT (%)	N/A
N/A	Flare Traversable LT?	N/A	N/A	Flare Traversable RT?	N/A
N/A	Landing Length (in)	N/A	N/A	DWS Provided?	N/A
N/A	Landing Width (in)	N/A	N/A	DWS Contrast?	N/A
N/A	Landing Slope (%)	N/A	N/A	DWS Length (in)	N/A
N/A	Landing X Slope (%)	N/A	N/A	DWS Full Width?	N/A
N/A	Landing Curb? (Y/N)	N/A	N/A	DWS Offset (in)	N/A
N/A	Shared Landing?	N/A			
N/A	Gutter Ponding?	N/A	N/A	Gutter Slope (%)	N/A
N/A	Gutter Lip Ht (in)	N/A	N/A	Gutter X Slope (%)	N/A
N/A	Painted X Walk1?	No	N/A	Painted X Walk2?	No
	X Walk 1 Direction	To E		X Walk 2 Direction	To N
N/A	X Walk 1 Width (in)	N/A	N/A	X Walk 2 Width (in)	N/A
	X Walk 1 Slope (%)	0.3		X Walk 2 Slope (%)	1.3
	X Walk 1 X Slope (%)	2.8		X Walk 2 X Slope (%)	1.6

Remove & Replace Curb Ramp With Two New Directional Ramps or Equivalent.
