Access Compliance Report

Public Rights-of-Way

(Curb Ramps)

Intersection ID: 10468	Main Street: E_35TH_ST	Cross Street: WHITING_AV	Location: SW
ADA ID: AEB5554A9FFE	Ramp Type: Combination1	Initial Pass/Fail: Fail	Overall Compliance: No
Severity Score: 10			
Codes/Mitigation Info/Possible Solution		Field Measurements/Component Compliance

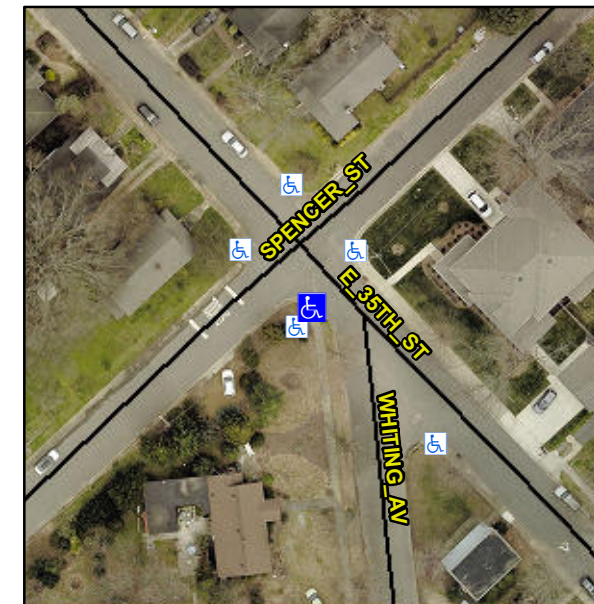
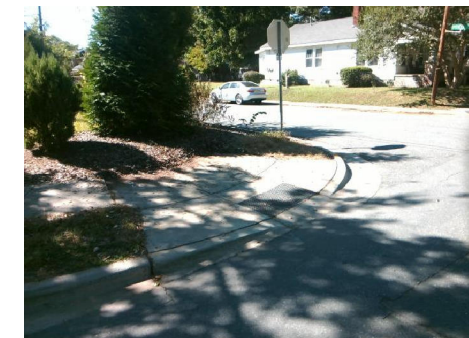
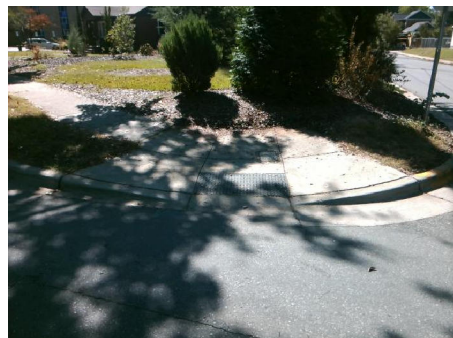
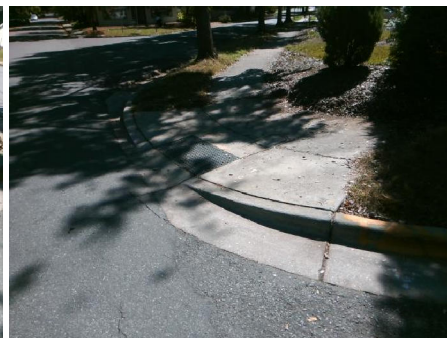
RT RP < 5%

Not Found, R304.5.1, R304.5.3

Compliance	Description	Data	Compliance	Description	Data
N/A	Ramp Length LT (in)	37.5	N/A	Ramp Length RT (in)	27.0
Yes	Ramp Width LT (in)	61.0	Yes	Ramp Width RT (in)	61.0
Yes	Ramp Slope LT (%)	7.9	Yes	Ramp Slope RT (%)	2.1
No	Ramp XSlope LT (%)	3.8	No	Ramp XSlope RT (%)	2.9
N/A	Ramp Length (in)	48.0	Yes	Ramp Slope (%)	7.2
No	Ramp Width (in)	46.5	Yes	Ramp XSlope (%)	1.0
N/A	Flare Type LT	N/A	N/A	Flare Type RT	N/A
N/A	Flare Slope LT (%)	N/A	N/A	Flare Slope RT (%)	N/A
N/A	Flare Traversable LT?	N/A	N/A	Flare Traversable RT?	N/A
N/A	Landing Length (in)	N/A	N/A	DWS Provided?	N/A
N/A	Landing Width (in)	N/A	N/A	DWS Contrast?	N/A
N/A	Landing Slope (%)	N/A	N/A	DWS Length (in)	N/A
N/A	Landing X Slope (%)	N/A	N/A	DWS Full Width?	N/A
N/A	Landing Curb? (Y/N)	N/A	N/A	DWS Offset (in)	N/A
N/A	Shared Landing?	N/A			
N/A	Gutter Ponding?	N/A	N/A	Gutter Slope (%)	N/A
N/A	Gutter Lip Ht (in)	N/A	N/A	Gutter X Slope (%)	N/A
N/A	Painted X Walk1?	No	N/A	Painted X Walk2?	N/A

Possible Solutions:

Remove & Replace Entire Ramp.
