Access Compliance Report

Public Rights-of-Way

(Curb Ramps)

Intersection ID: 3307	Main Street: SUTTONVIEW_DR	Cross Street: LOOKOUT_POINT_DR	Location: W
ADA ID: AEC63AAF4F07	Ramp Type: Perp	Initial Pass/Fail: Fail	Overall Compliance: No
Severity Score: 13.75			
Codes/Mitigation Info/Possible Solution		Field Measurements/Component Compliance

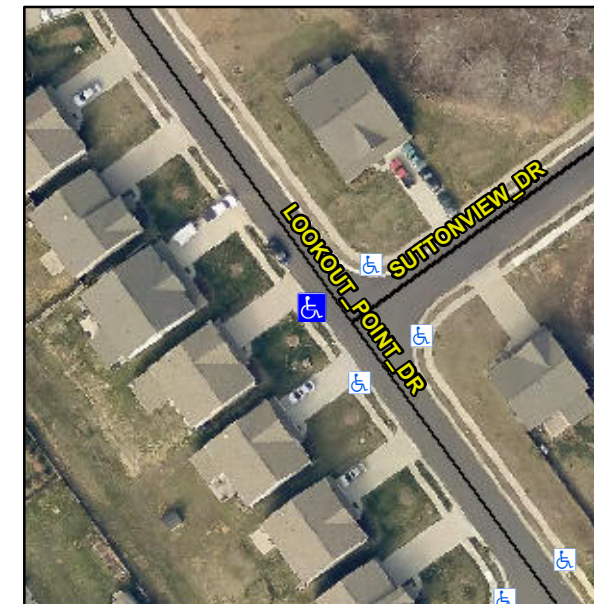
Not Found, R304.2.2, R304.5.3

Compliance	Description	Data	Compliance	Description	Data
N/A	Ramp Length (in)	48.5	No	Ramp Slope (%)	9.0
Yes	Ramp Width (in)	48.0	No	Ramp XSlope (%)	2.2
N/A	Flare Type LT	N/A	N/A	Flare Type RT	N/A
N/A	Flare Slope LT (%)	N/A	N/A	Flare Slope RT (%)	N/A
N/A	Flare Traversable LT?	N/A	N/A	Flare Traversable RT?	N/A
N/A	Landing Length (in)	N/A	N/A	DWS Provided?	N/A
N/A	Landing Width (in)	N/A	N/A	DWS Contrast?	N/A
N/A	Landing Slope (%)	N/A	N/A	DWS Length (in)	N/A
N/A	Landing X Slope (%)	N/A	N/A	DWS Full Width?	N/A
N/A	Landing Curb? (Y/N)	N/A	N/A	DWS Offset (in)	N/A
N/A	Shared Landing?	N/A			
N/A	Gutter Ponding?	N/A	N/A	Gutter Slope (%)	N/A
N/A	Gutter Lip Ht (in)	N/A	N/A	Gutter X Slope (%)	N/A
N/A	Painted X Walk1?	No	N/A	Painted X Walk2?	N/A
	X Walk 1 Direction	To NE		X Walk 2 Direction	N/A
N/A	X Walk 1 Width (in)	N/A	N/A	X Walk 2 Width (in)	N/A
	X Walk 1 Slope (%)	1.9		X Walk 2 Slope (%)	N/A
	X Walk 1 X Slope (%)	1.3		X Walk 2 X Slope (%)	N/A

N/A	Ramp inside XWalk1?	N/A	N/A	Ramp inside XWalk2?	N/A
	Road Slope (%)	N/A	N/A	Clear Space?	N/A
	Road X Slope (%)	N/A	N/A	Clear Space to XWalk (in)	N/A
N/A	Any Obstructions?	N/A	N/A	Storm Grate/Utility Hazard?	N/A
	Obstruction Type			Storm Grate/Utility Type	
		N/A			N/A
			Yes	Surface Condition? (G/P)	Good

Possible Solutions:

Remove & Replace Entire Ramp.

Total Cost: \$ 1850.00
