## Access Compliance Report Public Rights-of-Way (Curb Ramps)

Intersection ID: 4581	Main Street, ISLAND DARK CD				Straat		Location:	SW		
	Main Street: ISLAND_PARK_CR			Cross Street: MALLARD_CREEK_RD						
ADA ID: AEE50AB41743 Ramp Type: Perp			Initial Pass/Fail: Fail Overall Compliance: No					o Severity Score:	33.75	
Codes/Mitigation Info/Possible Solution			Field Measurements/Component Compliance							
6	P	Possible Solutions:			Compliance Description Data				Compliance Description D	
SUMMERCROFT IM	112 22	Remove & Replace Entire R	Ramp.		N/A	Ramp Length (in)	60.0	No	Ramp Slope (%)	9.6
A CONTRACT OF A	ATT OF THE OWNER	-			No	Ramp Width (in)	40.0	No	Ramp XSlope (%)	5.3
the second s	A TANK				N/A	Flare Type LT	N/A	N/A	Flare Type RT	N/A
					N/A	Flare Slope LT (%)	N/A	N/A	Flare Slope RT (%)	N/A
ISLAND	PARK				N/A	Flare Traversable L	T? <b>N/A</b>	N/A	Flare Traversable RT?	N/A
A LOW MAN					N/A	Landing Length (in)	N/A	N/A	DWS Provided?	N/A
	SI	urveyor Notes:			N/A	Landing Width (in)	N/A	N/A	DWS Contrast?	N/A

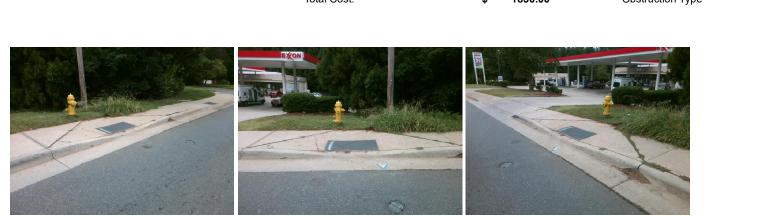
j 3	N/A			N/A	Landing Slope (%)	N/A	N/A	DWS Length (in)	N/A
	1991 50				N/A	Landing X Slope (%	) N/A	N/A	DWS Full Width?	N/A
	Con the				N/A	Landing Curb? (Y/N	l) N/A	N/A	DWS Offset (in)	N/A
					N/A	Shared Landing?	N/A			
	PI	ROW/ADA:			N/A	Gutter Ponding?	N/A	N/A	Gutter Slope (%)	N/A
		R304.5.1, R304.2.2, R304.5	.3		N/A	Gutter Lip Ht (in)	N/A	N/A	Gutter X Slope (%)	N/A

-		N/A	Painted X Walk1?	No	N/A	Painted X Walk2?	N/A
	- the					X Walk 1 Direction	To E		X Walk 2 Direction	N/A
	1				N/A	X Walk 1 Width (in)	N/A	N/A	X Walk 2 Width (in)	N/A
Street 1 Name MALLARD C	REEK RD					X Walk 1 Slope (%)	4.1		X Walk 2 Slope (%)	N/A
Stop Condition-Street 2	None					X Walk 1 X Slope (%	%) 5.1		X Walk 2 X Slope (%)	N/A
Street 2 Name	N/A				N/A	Ramp inside XWalk	1? <b>N/A</b>	N/A	Ramp inside XWalk2?	N/A
Stop Condition-Street 1	N/A					Road Slope (%)	N/A	N/A	Clear Space?	N/A
						Road X Slope (%)	N/A	N/A	Clear Space to XWalk (in)	N/A
					N/A	Any Obstructions?	N/A	N/A	Storm Grate/Utility Hazard?	N/A
	Тс	otal Cost:	\$ 1	850.00		Obstruction Type			Storm Grate/Utility Type	ľ
							N/A			N/A
