# Access Compliance Report

## Public Rights-of-Way (Curb Ramps)

| Intersection ID: 52448 | Main Street: WOODWARD_AV | Cross Street: DOUBLE_OAKS_RD | Location: SE |
| ADA ID: AEE66F0F6CC5 | Ramp Type: Directional1 | Initial Pass/Fail: Pass | Overall Compliance: No |

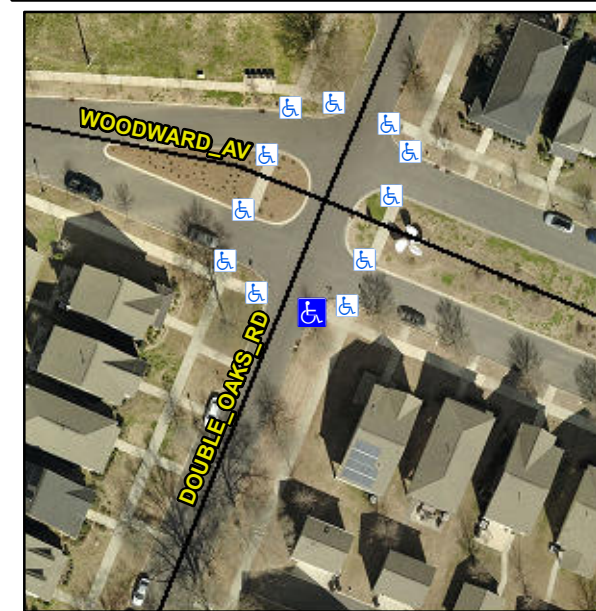
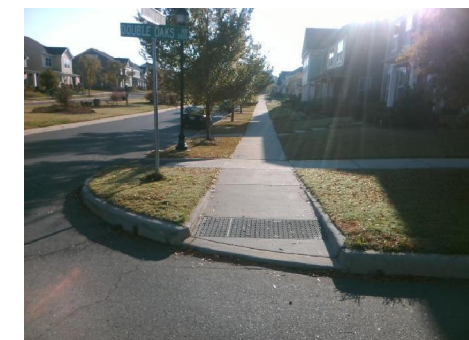
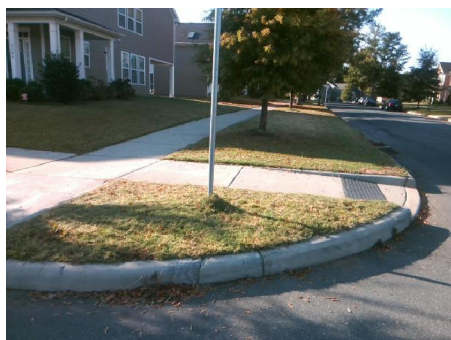
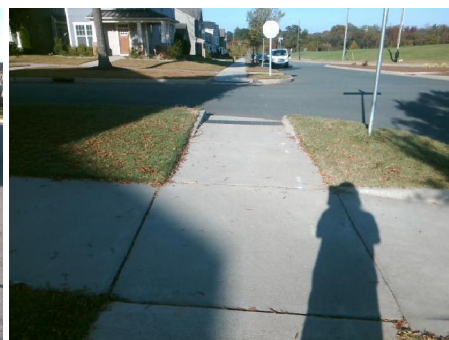
| Severity Score: 15.25 | | | |

| Compliance | Description | Data | Compliance | Description | Data |
|---|---|---|---|---|---|
| Yes | Ramp Slope (%) | 7.8 | No | Grade Break XSlope (%) | 2.8 |
| No | Ramp XSlope (%) | 2.5 | | | |
| No | Landing X Slope (%) | 2.1 | Yes | DWS Full Width? | Yes |
| No | Gutter Lip Ht (in) | 2.0 | Yes | Gutter X Slope (%) | 0.8 |

**Remove & Replace Entire Ramp.  
Grind Gutter Lip.**

**R304.5.3, R302.7.2**

Total Cost: \$ 1800.00
