Access Compliance Report

Public Rights-of-Way

(Curb Ramps)

Intersection ID: 10829	Main Street: E_34TH_ST	Cross Street: HOLT_ST	Location: S
ADA ID: AEE738F621C8	Ramp Type: Perp	Initial Pass/Fail: Fail	Overall Compliance: No
Codes/Mitigation Info/Possible Solution		Field Measurements/Component Compliance	
Severity Score: 21.25

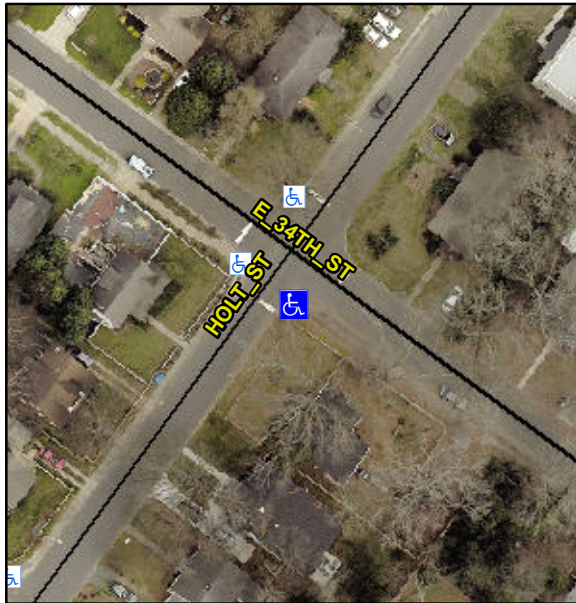
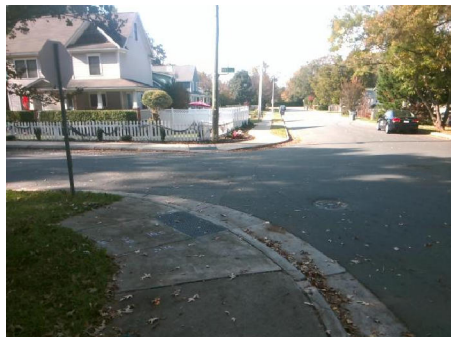
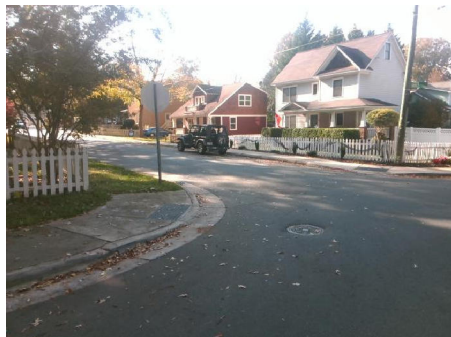
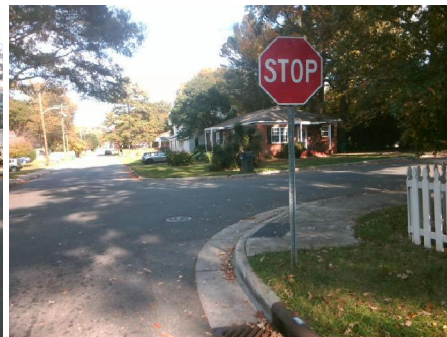
Not Found, R304.5.1, R304.2.2

Compliance	Description	Data	Compliance	Description	Data
N/A	Ramp Length (in)	72.5	No	Ramp Slope (%)	10.5
No	Ramp Width (in)	44.0	Yes	Ramp XSlope (%)	0.9
N/A	Flare Type LT	N/A	N/A	Flare Type RT	N/A
N/A	Flare Slope LT (%)	N/A	N/A	Flare Slope RT (%)	N/A
N/A	Flare Traversable LT?	N/A	N/A	Flare Traversable RT?	N/A
N/A	Landing Length (in)	N/A	N/A	DWS Provided?	N/A
N/A	Landing Width (in)	N/A	N/A	DWS Contrast?	N/A
N/A	Landing Slope (%)	N/A	N/A	DWS Length (in)	N/A
N/A	Landing X Slope (%)	N/A	N/A	DWS Full Width?	N/A
N/A	Landing Curb? (Y/N)	N/A	N/A	DWS Offset (in)	N/A
N/A	Shared Landing?	N/A			
N/A	Gutter Ponding?	N/A	N/A	Gutter Slope (%)	N/A
N/A	Gutter Lip Ht (in)	N/A	N/A	Gutter X Slope (%)	N/A
N/A	Painted X Walk1?	No	N/A	Painted X Walk2?	N/A
	X Walk 1 Direction	To NW		X Walk 2 Direction	N/A
N/A	X Walk 1 Width (in)	N/A	N/A	X Walk 2 Width (in)	N/A
	X Walk 1 Slope (%)	0.2		X Walk 2 Slope (%)	N/A
	X Walk 1 X Slope (%)	2.3		X Walk 2 X Slope (%)	N/A

Remove & Replace Entire Ramp.
