Access Compliance Report Public Rights-of-Way (Curb Ramps)

Intersection ID: 16015 Main Street: ELLINGTON_ST Cross Street: WHEATLEY_AV Location: SW ADA ID: AEE8A32EE529 **Overall Compliance: No** Ramp Type: Perp Initial Pass/Fail: Pass **Severity Score:** 15

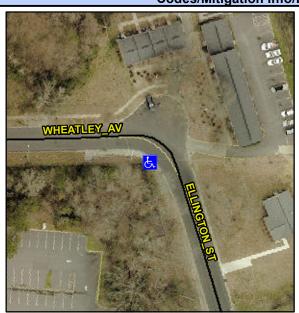
Field Measurements/Component Compliance						
Comp	liance Description	Data	Comp	liance Description	Data	
N/A	Ramp Length (in)	63.0	Yes	Ramp Slope (%)	5.2	
Yes	Ramp Width (in)	48.0	Yes	Ramp XSlope (%)	1.8	
N/A	Flare Type LT	Sloped	N/A	Flare Type RT	N/A	
N/A	Flare Slope LT (%)	5.1	Yes	Flare Slope RT (%)	0.3	
N/A	Flare Traversable LT?	Yes	N/A	Flare Traversable RT?	Yes	
No	Landing Length (in)	N/A	Yes	DWS Provided?	Yes	
No	Landing Width (in)	N/A	Yes	DWS Contrast?	Yes	
No	Landing Slope (%)	N/A	Yes	DWS Length (in)	24.5	
No	Landing X Slope (%)	N/A	Yes	DWS Full Width?	Yes	
N/A	Landing Curb? (Y/N)	No	Yes	DWS Offset (in)	0.0	
N/A	Shared Landing?	No				
Yes	Gutter Ponding?	No	No	Gutter Slope (%)	10.4	
Yes	Gutter Lip Ht (in)	0.0	Yes	Gutter X Slope (%)	1.8	
N/A	Painted X Walk1?	No	N/A	Painted X Walk2?	N/A	
	X Walk 1 Direction	To E		X Walk 2 Direction	N/A	
N/A	X Walk 1 Width (in)	N/A	N/A	X Walk 2 Width (in)	N/A	
	X Walk 1 Slope (%)	2.8		X Walk 2 Slope (%)	N/A

X Walk 1 X Slope (%)	0.5		X Walk 2 X Slope (%)	N/A	
N/A	Ramp inside XWalk1?	N/A	N/A	Ramp inside XWalk2?	N/A	
	Road Slope (%)	N/A	N/A	Clear Space?	Yes	
	Road X Slope (%)	N/A	N/A	Clear Space to XWalk (in)	N/A	
Yes	Any Obstructions?	No	Yes	Storm Grate/Utility Hazard?	No	
	Obstruction Type			Storm Grate/Utility Type		
		N/A			N/A	
			Yes	Surface Condition? (G/P)	Good

Possible Solutions:	2
Remove & Replace Entire Ramp.	N
Remove & Replace Gutter.	Y
	N
	1
	1
	1
Surveyor Notes:	1
N/A	1
	1
	1
	1
PROW/ADA:	١
Not Found, R304.2.1, R304.2.2-Perp,	Y
R304.3.2-Para, R304.5.3, R304.5.4	١
	ŀ

1		
PROW/ADA:		!		
Not Found, R304.2.1, R304.2.2-Perp, R304.3.2-Para, R304.5.3, R304.5.4				
		I		
		ı		
Total Cost:	\$ 2600	.00
