# Access Compliance Report

## Public Rights-of-Way

| Intersection ID: 5304 | Main Street: NORTHWOODS_FOREST_DR | Cross Street: PINE_MOUNTAIN_RD | Location: SE |
| ADA ID: AF05A9C31823 | Ramp Type: Perp | Initial Pass/Fail: Fail | Overall Compliance: No |

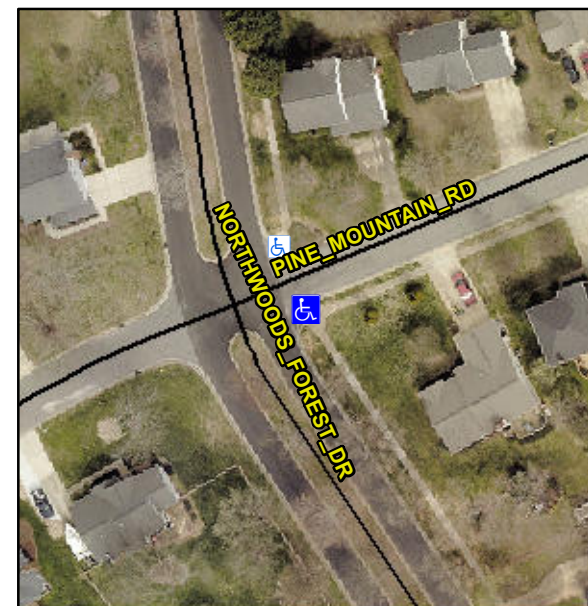
| | | Severity Score: 12.5 | |

**Not Found, R304.5.3**

| Compliance | Description | Data | Compliance | Description | Data |
|---|---|---|---|---|---|
| Yes | Ramp Width (in) | 48.0 | No | Ramp XSlope (%) | 5.5 |

**Remove & Replace Entire Ramp.**

Total Cost: \$ 1850.00
