Access Compliance Report Public Rights-of-Way (Curb Ramps)

Intersection ID: 52452Main Street: PAT_GARRETT_STCross Street: BENDING_BIRCH_PLLocation:NEADA ID: AF0FD6118E7BRamp Type: PerpInitial Pass/Fail: FailOverall Compliance: NoSeverity Score: 12.5

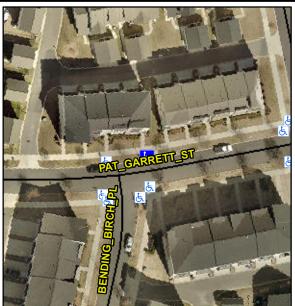
- OSSIDIE SOIULIOII			i leid Measurements/Component Compilance					
Possible Solutions:		Compliance Description		Data	Data Compliance Description			
Remove & Replace Entire R	lamp.	N/A	Ramp Length (in)	95.0	No	Ramp Slope (%)

•	•	Yes	Ramp Width (in)	68.0	Yes	Ramp XSlope (%)		
		N/A	Flare Type LT	N/A	N/A	Flare Type RT		
		N/A	Flare Slope LT (%)	N/A	N/A	Flare Slope RT (%)		
		N/A	Flare Traversable LT?	N/A	N/A	Flare Traversable RT?		
		N/A	Landing Length (in)	N/A	N/A	DWS Provided?		
Surveyor Notes:		N/A	Landing Width (in)	N/A	N/A	DWS Contrast?		
N/A		N/A	Landing Slope (%)	N/A	N/A	DWS Length (in)		
		N/A	Landing X Slope (%)	N/A	N/A	DWS Full Width?		
		N/A	Landing Curb? (Y/N)	N/A	N/A	DWS Offset (in)		
		N/A	Shared Landing?	N/A				
PROW/ADA:		N/A	Gutter Ponding?	N/A	N/A	Gutter Slope (%)		
R304.2.2		N/A	Gutter Lip Ht (in)	2.0	N/A	Gutter X Slope (%)		
		N/A	Painted X Walk1?	No	N/A	Painted X Walk2?		
			X Walk 1 Direction	To S		X Walk 2 Direction		
		N/A	X Walk 1 Width (in)	N/A	N/A	X Walk 2 Width (in)		
			X Walk 1 Slope (%)	1.7		X Walk 2 Slope (%)		
			X Walk 1 X Slope (%)	1.8		X Walk 2 X Slope (%)		
		N/A	Ramp inside XWalk1?	N/A	N/A	Ramp inside XWalk2?

Road Slope (%)	N/A	N/A	Clear Space?		
			Road X Slope (%)	N/A	N/A	Clear Space to XWalk (in)		
		N/A	Any Obstructions?	N/A	N/A	Storm Grate/Utility Hazard?		
Total Cost:	\$ 1850.00		Obstruction Type			Storm Grate/Utility Type		
				N/A
