Access Compliance Report Public Rights-of-Way (Curb Ramps)

Intersection ID: 17544	Main Street: MANHASSET_RD			Street:	MURRAYHILL_RD	Location:	SW		
ADA ID: AF149032C930	Ramp Type: PerpDiag			Initial Pass/Fail: Fail Overall Compliance: No				o Severity Score:	8.75
Codes/Mitigation Info/Possible Solution				Field Measurements/Component Compliance					
		Possible Solutions:		Compliance Description		Data	Data Compliance Description		Data
	1 Bring	Remove & Replace Curb Ramp W	lith	N/A	Ramp Length (in)	60.0	Yes	Ramp Slope (%)	6.9

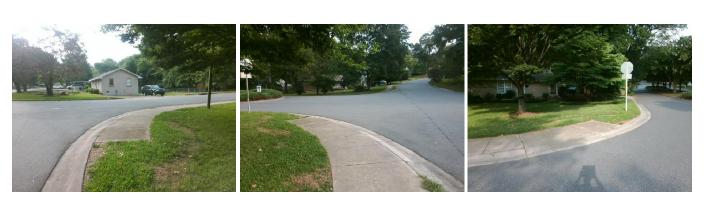
i.		Two New Directional Ramps or Equivalent.		No	Ramp Width (in)	40.0	Yes	Ramp XSlope (%)	0.3
				N/A	Flare Type LT	N/A	N/A	Flare Type RT	N/A
				N/A	Flare Slope LT (%)	N/A	N/A	Flare Slope RT (%)	N/A
MANIHASSET	RD			N/A	Flare Traversable LT?	N/A	N/A	Flare Traversable RT?	N/A
A REAL PROPERTY AND A REAL	Charlon Charles			N/A	Landing Length (in)	N/A	N/A	DWS Provided?	N/A
the second se		Surveyor Notes:		N/A	Landing Width (in)	N/A	N/A	DWS Contrast?	N/A
		N/A		N/A	Landing Slope (%)	N/A	N/A	DWS Length (in)	N/A
				N/A	Landing X Slope (%)	N/A	N/A	DWS Full Width?	N/A
STATS NO.				N/A	Landing Curb? (Y/N)	N/A	N/A	DWS Offset (in)	N/A
A MANA				N/A	Shared Landing?	N/A			
	A CONTRACTOR	PROW/ADA:		N/A	Gutter Ponding?	N/A	N/A	Gutter Slope (%)	N/A
	A Britishing	R304.5.1		N/A	Gutter Lip Ht (in)	N/A	N/A	Gutter X Slope (%)	N/A
	and the second second			N/A	Painted X Walk1?	No	N/A	Painted X Walk2?	No
				X Walk 1 Direction	To E		X Walk 2 Direction	To N

Succession and				N/A	X Walk 1 Width (in)	N/A	N/A	X Walk 2 Width (in)	N/A
Street 1 Name	MURRAYHILL RD	-			X Walk 1 Slope (%)	6.3		X Walk 2 Slope (%)	5.6
Stop Condition-Street 2	None				X Walk 1 X Slope (%)	2.9		X Walk 2 X Slope (%)	3.0
Street 2 Name	MANHASSET RD			N/A	Ramp inside XWalk1?	N/A	N/A	Ramp inside XWalk2?	N/A
Stop Condition-Street 1	StopSign				Road Slope (%)	0.1	N/A	Clear Space?	N/A
					Road X Slope (%)	7.0	N/A	Clear Space to XWalk (in)	N/A
				N/A	Any Obstructions?	N/A	N/A	Storm Grate/Utility Hazard?	N/A
		Total Cost: \$ 32	200.00		Obstruction Type			Storm Grate/Utility Type	
						N/A			N/A
