Intersection ID: 22285	Main Street: QUAIL_HOLLOW_RD	Cross Street: HAMPTONRIDGE_DR	Location:	N
ADA ID: AF182688C6DA	Ramp Type: PerpDiag	Initial Pass/Fail: Fail	Overall Compliance: No	Severity Score: 13.75

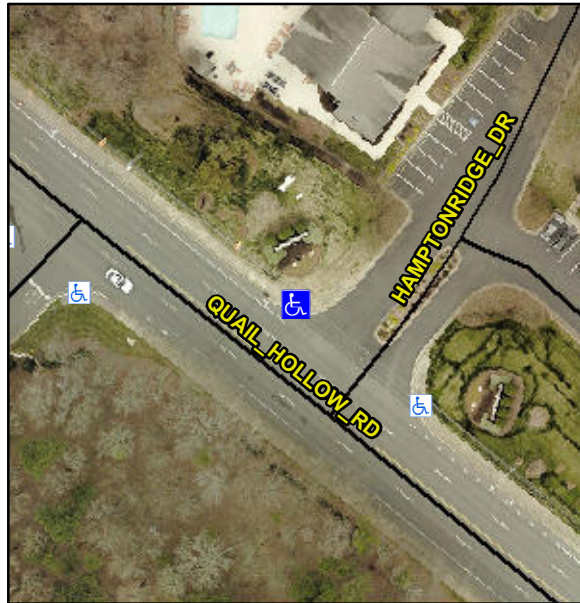
Compliance	Description	Data	Compliance	Description	Data
N/A	Ramp Length (in)	54.0	No	Ramp Slope (%)	9.6
Yes	Ramp Width (in)	48.0	Yes	Ramp XSlope (%)	4.1
N/A	Flare Type LT	N/A	N/A	Flare Type RT	N/A
N/A	Flare Slope LT (%)	N/A	N/A	Flare Slope RT (%)	N/A
N/A	Flare Traversable LT?	N/A	N/A	Flare Traversable RT?	N/A
N/A	Landing Length (in)	N/A	N/A	DWS Provided?	N/A
N/A	Landing Width (in)	N/A	N/A	DWS Contrast?	N/A
N/A	Landing Slope (%)	N/A	N/A	DWS Length (in)	N/A
N/A	Landing X Slope (%)	N/A	N/A	DWS Full Width?	N/A
N/A	Landing Curb? (Y/N)	N/A	N/A	DWS Offset (in)	N/A
N/A	Shared Landing?	N/A			
N/A	Gutter Ponding?	N/A	N/A	Gutter Slope (%)	N/A
N/A	Gutter Lip Ht (in)	N/A	N/A	Gutter X Slope (%)	N/A
N/A	Painted X Walk1?	No	N/A	Painted X Walk2?	No
	X Walk 1 Direction	To SW		X Walk 2 Direction	To SE
N/A	X Walk 1 Width (in)	N/A	N/A	X Walk 2 Width (in)	N/A
	X Walk 1 Slope (%)	6.7		X Walk 2 Slope (%)	4.2
	X Walk 1 X Slope (%)	1.1		X Walk 2 X Slope (%)	5.9

N/A	Ramp inside XWalk1?	N/A	N/A	Ramp inside XWalk2?	N/A
	Road Slope (%)	4.4	N/A	Clear Space?	N/A
	Road X Slope (%)	4.6	N/A	Clear Space to XWalk (in)	N/A
N/A	Any Obstructions?	N/A	N/A	Storm Grate/Utility Hazard?	N/A
	Obstruction Type			Storm Grate/Utility Type	
		N/A			N/A
			Yes	Surface Condition? (G/P)	Good

Remove & Replace Curb Ramp With Two New Directional Ramps or Equivalent.

R304.2.2
