# Access Compliance Report

## Public Rights-of-Way

### (Curb Ramps)

Intersection ID: 54260	Main Street: BALLANTYNE_COMMONS_PY	Cross Street: BLACK_FOREST_LN	Location: SE
ADA ID: AF1B83C2B011	Ramp Type: Perp	Initial Pass/Fail: Fail	Overall Compliance: No
Severity Score: 25			
Codes/Mitigation Info/Possible Solution		Field Measurements/Component Compliance

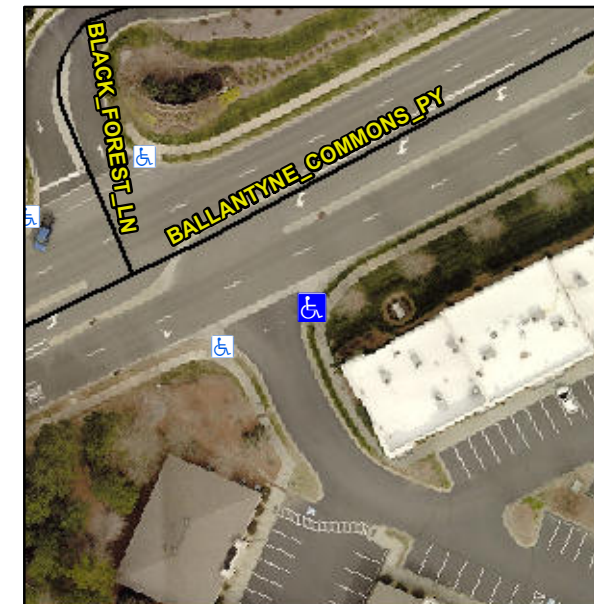
**Not Found, R304.5.3**

Compliance	Description	Data	Compliance	Description	Data
N/A	Ramp Length (in)	115.5	Yes	Ramp Slope (%)	7.5
Yes	Ramp Width (in)	51.0	No	Ramp XSlope (%)	11.3
N/A	Flare Type LT	N/A	N/A	Flare Type RT	N/A
N/A	Flare Slope LT (%)	N/A	N/A	Flare Slope RT (%)	N/A
N/A	Flare Traversable LT?	N/A	N/A	Flare Traversable RT?	N/A
N/A	Landing Length (in)	N/A	N/A	DWS Provided?	N/A
N/A	Landing Width (in)	N/A	N/A	DWS Contrast?	N/A
N/A	Landing Slope (%)	N/A	N/A	DWS Length (in)	N/A
N/A	Landing X Slope (%)	N/A	N/A	DWS Full Width?	N/A
N/A	Landing Curb? (Y/N)	N/A	N/A	DWS Offset (in)	N/A
N/A	Shared Landing?	N/A			
N/A	Gutter Ponding?	N/A	N/A	Gutter Slope (%)	N/A
N/A	Gutter Lip Ht (in)	N/A	N/A	Gutter X Slope (%)	N/A
N/A	Painted X Walk1?	No	N/A	Painted X Walk2?	N/A
	X Walk 1 Direction	To W		X Walk 2 Direction	N/A
N/A	X Walk 1 Width (in)	N/A	N/A	X Walk 2 Width (in)	N/A
	X Walk 1 Slope (%)	1.2		X Walk 2 Slope (%)	N/A
	X Walk 1 X Slope (%)	11.4		X Walk 2 X Slope (%)	N/A

N/A	Ramp inside XWalk1?	N/A	N/A	Ramp inside XWalk2?	N/A
	Road Slope (%)	N/A	N/A	Clear Space?	N/A
	Road X Slope (%)	N/A	N/A	Clear Space to XWalk (in)	N/A
N/A	Any Obstructions?	N/A	N/A	Storm Grate/Utility Hazard?	N/A
	Obstruction Type			Storm Grate/Utility Type	
		N/A			N/A
		Yes		Surface Condition? (G/P)	Good

Possible Solutions:

**Remove & Replace Entire Ramp.**
