# Access Compliance Report

## Public Rights-of-Way

### (Curb Ramps)

Intersection ID: 30057	Main Street: SOUTHWIND_DR	Cross Street: SUNSET_VILLAGE_DR	Location:	N
ADA ID: AF29D64AF695	Ramp Type: Combination1Diag	Initial Pass/Fail: Fail	Overall Compliance: No	Severity Score: 0

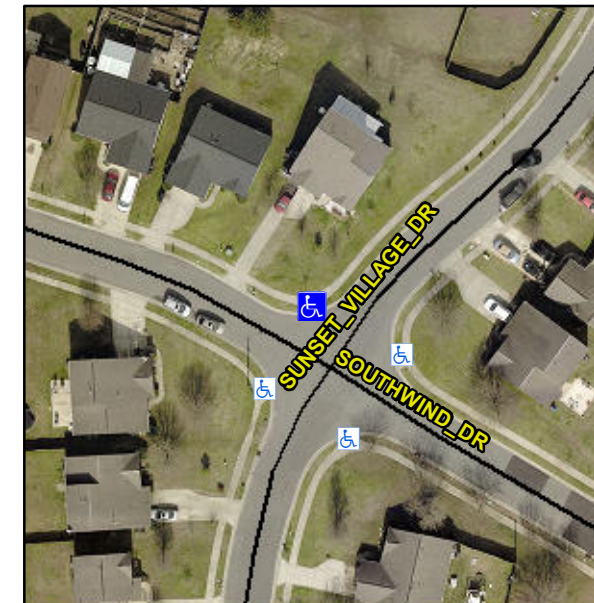
Compliance	Description	Data	Compliance	Description	Data
N/A	Ramp Length LT (in)	46.0	N/A	Ramp Length RT (in)	46.0
Yes	Ramp Width LT (in)	59.0	Yes	Ramp Width RT (in)	60.5
No	Ramp Slope LT (%)	9.2	Yes	Ramp Slope RT (%)	5.0
Yes	Ramp XSlope LT (%)	1.4	Yes	Ramp XSlope RT (%)	0.4
N/A	Ramp Length (in)	55.5	Yes	Ramp Slope (%)	6.9
Yes	Ramp Width (in)	54.0	No	Ramp XSlope (%)	4.0
N/A	Flare Type LT	N/A	N/A	Flare Type RT	N/A
N/A	Flare Slope LT (%)	N/A	N/A	Flare Slope RT (%)	N/A
N/A	Flare Traversable LT?	N/A	N/A	Flare Traversable RT?	N/A
N/A	Landing Length (in)	N/A	N/A	DWS Provided?	N/A
N/A	Landing Width (in)	N/A	N/A	DWS Contrast?	N/A
N/A	Landing Slope (%)	N/A	N/A	DWS Length (in)	N/A
N/A	Landing X Slope (%)	N/A	N/A	DWS Full Width?	N/A
N/A	Landing Curb? (Y/N)	N/A	N/A	DWS Offset (in)	N/A
N/A	Shared Landing?	N/A			
N/A	Gutter Ponding?	N/A	N/A	Gutter Slope (%)	N/A
N/A	Gutter Lip Ht (in)	N/A	N/A	Gutter X Slope (%)	N/A
N/A	Painted X Walk1?	No	N/A	Painted X Walk2?	No

X Walk 1 Direction	To SW		X Walk 2 Direction	To SE
	X Walk 1 Width (in)	N/A		X Walk 2 Width (in)	N/A
	X Walk 1 Slope (%)	3.6		X Walk 2 Slope (%)	0.2
	X Walk 1 X Slope (%)	2.5		X Walk 2 X Slope (%)	4.8
N/A	Ramp inside XWalk1?	N/A	N/A	Ramp inside XWalk2?	N/A
	Road Slope (%)	4.7		Clear Space?	N/A
	Road X Slope (%)	1.2	N/A	Clear Space to XWalk (in)	N/A
			N/A	Any Obstruction?	N/A
				Obstruction Type	N/A
			N/A	Storm Grate/Utility Hazard?	N/A
				Storm Grate/Utility Type	N/A
			Yes	Surface Condition? (G/P)	Good
				Curb Slope (%)	0.9

**Remove & Replace Curb Ramp With Two New Directional Ramps or Equivalent.**

**R304.5.3, R304.3.2**
