# Access Compliance Report

## Public Rights-of-Way

### (Curb Ramps)

Intersection ID: 45501	Main Street: BUGGY_HORSE_RD	Cross Street: CAPTAIN_ARDREY_RD	Location: E
ADA ID: AF2E57D967A0	Ramp Type: PerpDiag	Initial Pass/Fail: Fail	Overall Compliance: No
Severity Score: 22.5			
Codes/Mitigation Info/Possible Solution		Field Measurements/Component Compliance

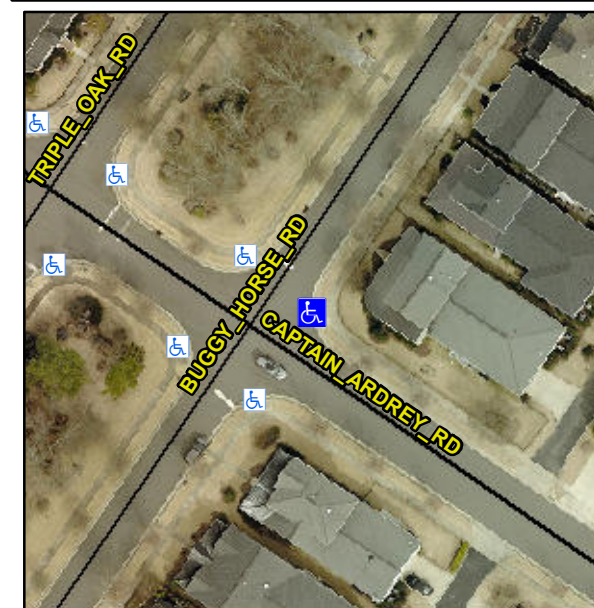
**Not Found, R304.5.1, R304.2.2, R304.5.3**

Compliance	Description	Data	Compliance	Description	Data
N/A	Ramp Length (in)	72.0	No	Ramp Slope (%)	11.4
No	Ramp Width (in)	36.0	No	Ramp XSlope (%)	5.0
N/A	Flare Type LT	N/A	N/A	Flare Type RT	N/A
N/A	Flare Slope LT (%)	N/A	N/A	Flare Slope RT (%)	N/A
N/A	Flare Traversable LT?	N/A	N/A	Flare Traversable RT?	N/A
N/A	Landing Length (in)	N/A	N/A	DWS Provided?	N/A
N/A	Landing Width (in)	N/A	N/A	DWS Contrast?	N/A
N/A	Landing Slope (%)	N/A	N/A	DWS Length (in)	N/A
N/A	Landing X Slope (%)	N/A	N/A	DWS Full Width?	N/A
N/A	Landing Curb? (Y/N)	N/A	N/A	DWS Offset (in)	N/A
N/A	Shared Landing?	N/A			
N/A	Gutter Ponding?	N/A	N/A	Gutter Slope (%)	N/A
N/A	Gutter Lip Ht (in)	N/A	N/A	Gutter X Slope (%)	N/A
N/A	Painted X Walk1?	No	N/A	Painted X Walk2?	No
	X Walk 1 Direction	To NW		X Walk 2 Direction	To SW
N/A	X Walk 1 Width (in)	N/A	N/A	X Walk 2 Width (in)	N/A
	X Walk 1 Slope (%)	2.3		X Walk 2 Slope (%)	3.4
	X Walk 1 X Slope (%)	4.0		X Walk 2 X Slope (%)	3.3

N/A	Ramp inside XWalk1?	N/A	N/A	Ramp inside XWalk2?	N/A
	Road Slope (%)	2.0	N/A	Clear Space?	N/A
	Road X Slope (%)	2.0	N/A	Clear Space to XWalk (in)	N/A
N/A	Any Obstructions?	N/A	N/A	Storm Grate/Utility Hazard?	N/A
	Obstruction Type			Storm Grate/Utility Type	
		N/A			N/A
			Yes	Surface Condition? (G/P)	Good

**Remove & Replace Curb Ramp With Two New Directional Ramps or Equivalent.**
