Access Compliance Report

Public Rights-of-Way

(Curb Ramps)

Intersection ID: N/A	Main Street: BARRINGER_DR	Cross Street: MAYFLOWER_RD	Location: SW
ADA ID: AF33CD700593	Ramp Type: Directional1	Initial Pass/Fail: Pass	Overall Compliance: No
Codes/Mitigation Info/Possible Solution		Field Measurements/Component Compliance	
Severity Score: 17.75

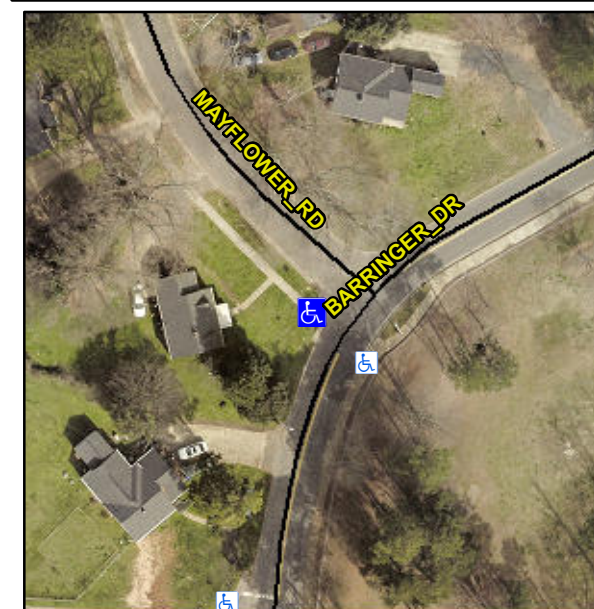
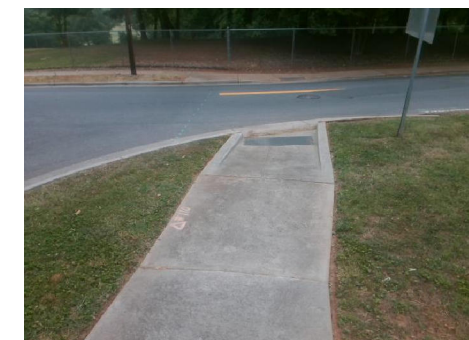
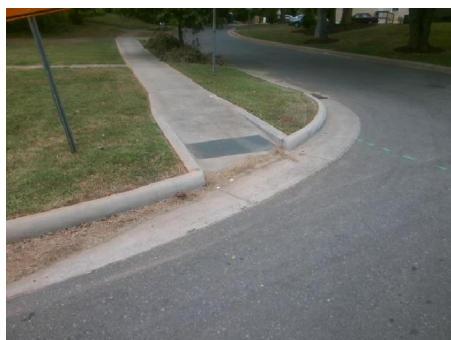
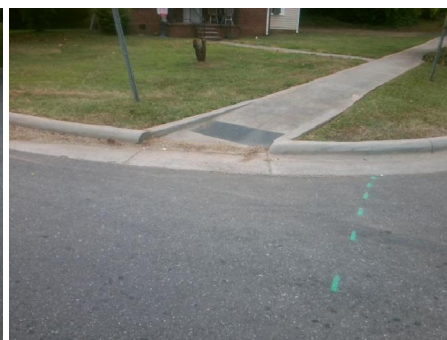
Compliance	Description	Data	Compliance	Description	Data
N/A	Ramp Length (in)	86.0	Yes	Grade Break?	Yes
Yes	Ramp Width (in)	52.0	No	Grade Break Slope (%)	6.1
Yes	Ramp Slope (%)	6.9	No	Grade Break XSlope (%)	3.0
No	Ramp XSlope (%)	2.3			
Yes	Flare Type LT	N/A	Yes	Flare Type RT	N/A
N/A	Flare Slope LT (%)	N/A	N/A	Flare Slope RT (%)	N/A
N/A	Flare Traversable LT?	No	N/A	Flare Traversable RT?	No
Yes	Landing Length (in)	75.0	Yes	DWS Provided?	Yes
Yes	Landing Width (in)	54.0	Yes	DWS Contrast?	Yes
No	Landing Slope (%)	3.9	Yes	DWS Length (in)	24.0
Yes	Landing X Slope (%)	1.1	No	DWS Full Width?	No
N/A	Landing Curb? (Y/N)	N/A	Yes	DWS Offset LT (in)	23.0
N/A	Shared Landing?	No	Yes	DWS Offset RT (in)	0.0
Yes	Gutter Ponding?	No	Yes	Gutter Slope (%)	0.5
No	Gutter Lip Ht (in)	1.0	Yes	Gutter X Slope (%)	1.3
N/A	Painted X Walk1?	No		Road Slope (%)	0.9
	X Walk 1 Direction	To E		Road X Slope (%)	1.0
	X Walk 1 Width (in)	N/A		Clear Space?	Yes

X Walk 1 Slope (%)	0.9	N/A	Clear Space to XWalk (in)	N/A
	X Walk 1 X Slope (%)	1.0	Yes	Storm Grate/Utility Hazard?	No
N/A	Ramp inside XWalk1?	N/A		Storm Grate/Utility Type	
Yes	Any Obstructions?	No			N/A
	Obstruction Type		Yes	Surface Condition? (G/P)	Good
			N/A	Curb Slope (%)	2.9

Possible Solutions:

**Remove & Replace Entire Ramp.
Grind Gutter Lip.**

**R304.5.3, R304.2.2-Perp, R304.3.2-
Para, R305.1.4, R302.7.2**
