# Access Compliance Report

## Public Rights-of-Way

### (Curb Ramps)

Intersection ID: 52452	Main Street: PAT_GARRETT_ST	Cross Street: BENDING_BIRCH_PL	Location: NW
ADA ID: AF3669177E35	Ramp Type: Perp	Initial Pass/Fail: Fail	Overall Compliance: No
			Severity Score: 13.75

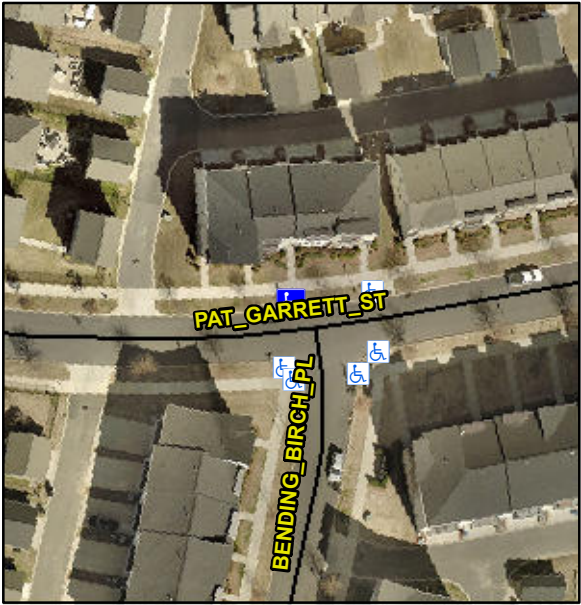
Compliance	Description	Data	Compliance	Description	Data
N/A	Ramp Length (in)	93.0	No	Ramp Slope (%)	8.9
Yes	Ramp Width (in)	67.0	No	Ramp XSlope (%)	3.0
N/A	Flare Type LT	N/A	N/A	Flare Type RT	N/A
N/A	Flare Slope LT (%)	N/A	N/A	Flare Slope RT (%)	N/A
N/A	Flare Traversable LT?	N/A	N/A	Flare Traversable RT?	N/A
N/A	Landing Length (in)	N/A	N/A	DWS Provided?	N/A
N/A	Landing Width (in)	N/A	N/A	DWS Contrast?	N/A
N/A	Landing Slope (%)	N/A	N/A	DWS Length (in)	N/A
N/A	Landing X Slope (%)	N/A	N/A	DWS Full Width?	N/A
N/A	Landing Curb? (Y/N)	N/A	N/A	DWS Offset (in)	N/A
N/A	Shared Landing?	N/A			
N/A	Gutter Ponding?	N/A	N/A	Gutter Slope (%)	N/A
N/A	Gutter Lip Ht (in)	1.5	N/A	Gutter X Slope (%)	N/A
N/A	Painted X Walk1?	No	N/A	Painted X Walk2?	N/A
	X Walk 1 Direction	To S		X Walk 2 Direction	N/A
N/A	X Walk 1 Width (in)	N/A	N/A	X Walk 2 Width (in)	N/A
	X Walk 1 Slope (%)	1.3		X Walk 2 Slope (%)	N/A
	X Walk 1 X Slope (%)	1.7		X Walk 2 X Slope (%)	N/A

N/A	Ramp inside XWalk1?	N/A	N/A	Ramp inside XWalk2?	N/A
	Road Slope (%)	N/A	N/A	Clear Space?	N/A
	Road X Slope (%)	N/A	N/A	Clear Space to XWalk (in)	N/A
N/A	Any Obstructions?	N/A	N/A	Storm Grate/Utility Hazard?	N/A
	Obstruction Type			Storm Grate/Utility Type	
		N/A			N/A
			Yes	Surface Condition? (G/P)	Good

Possible Solutions:				
	Remove & Replace Entire Ramp.				
	Surveyor Notes:				
	N/A				
	PROW/ADA:				
	R304.2.2, R304.5.3				
Street 1 Name	PAT GARRETT ST				
Stop Condition-Street 2	None				
Street 2 Name	N/A				
Stop Condition-Street 1	N/A				
Total Cost:		\$	1850.00
