Access Compliance Report Public Rights-of-Way (Curb Ramps)

Intersection ID: 10024355 Main Street: CRESCENT EXECUTIVE DR Cross Street: N/A Location: NE **ADA ID: AF4597A761AB** Ramp Type: PerpDiag Initial Pass/Fail: Fail **Overall Compliance: No Severity Score:** 12.5

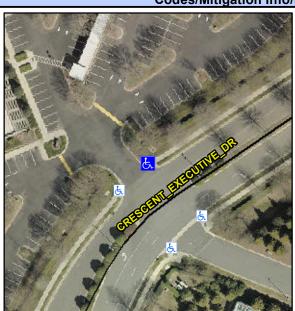
Compliance Description Data		Comp	liance Description	Data	
N/A	Ramp Length (in)	108.0	Yes	Ramp Slope (%)	7.3
Yes	Ramp Width (in)	60.0	No	Ramp XSlope (%)	5.9
N/A	Flare Type LT	N/A	N/A	Flare Type RT	N/A
N/A	Flare Slope LT (%)	N/A	N/A	Flare Slope RT (%)	N/A
N/A	Flare Traversable LT?	N/A	N/A	Flare Traversable RT?	N/A
N/A	Landing Length (in)	N/A	N/A	DWS Provided?	N/A
N/A	Landing Width (in)	N/A	N/A	DWS Contrast?	N/A
N/A	Landing Slope (%)	N/A	N/A	DWS Length (in)	N/A
N/A	Landing X Slope (%)	N/A	N/A	DWS Full Width?	N/A
N/A	Landing Curb? (Y/N)	N/A	N/A	DWS Offset (in)	N/A
N/A	Shared Landing?	N/A			
N/A	Gutter Ponding?	N/A	N/A	Gutter Slope (%)	N/A
N/A	Gutter Lip Ht (in)	N/A	N/A	Gutter X Slope (%)	N/A
N/A	Painted X Walk1?	No	N/A	Painted X Walk2?	No
	X Walk 1 Direction	To SW		X Walk 2 Direction	To SE
N/A	X Walk 1 Width (in)	N/A	N/A	X Walk 2 Width (in)	N/A
	X Walk 1 Slope (%)	4.6		X Walk 2 Slope (%)	0.1
	X Walk 1 X Slope (%)	4.6		X Walk 2 X Slope (%)	1.8

N/A	Ramp inside XWalk1?	N/A	N/A	Ramp inside XWalk2?	N/A
	Road Slope (%)	1.9	N/A	Clear Space?	N/A
	Road X Slope (%)	5.6	N/A	Clear Space to XWalk (in)	N/A
N/A	Any Obstructions?	N/A	N/A	Storm Grate/Utility Hazard?	N/A
	Obstruction Type		l	Storm Grate/Utility Type	
		N/A			N/A
			Yes	Surface Condition? (G/P)	Good

Remove & Replace Curb Ramp With **Two New Directional Ramps or** Equivalent.

R304.5.3
