## Access Compliance Report Public Rights-of-Way (Curb Ramps)

Intersection ID: 10041443 Main Street: WESTINGHOUSE\_BV Cross Street: N/A Location: NE
ADA ID: AF7666FF53D5 Ramp Type: Combination1Diag Initial Pass/Fail: Fail Overall Compliance: No Severity Score: 0

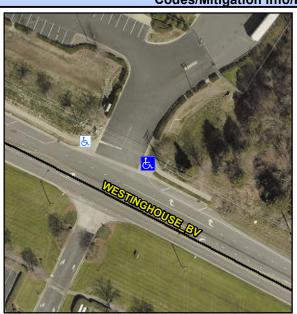
Compliance Description Data Compliance Description Data Ramp Length LT (in) N/A N/A 32.0 Ramp Length RT (in) 33.0 Yes Ramp Width LT (in) 60.0 Yes Ramp Width RT (in) 59.0 Yes No Ramp Slope LT (%) 9.6 Ramp Slope RT (%) 5.1 Ramp XSlope LT (%) 3.3 Yes Ramp XSlope RT (%) No 1.6 N/A Ramp Length (in) 48.0 Yes Ramp Slope (%) 4.1 48.0 No Ramp XSlope (%) Yes Ramp Width (in) 2.6 N/A Flare Type LT N/A N/A Flare Type RT N/A N/A N/A N/A Flare Slope LT (%) Flare Slope RT (%) N/A N/A Flare Traversable LT? N/A N/A Flare Traversable RT? N/A N/A Landing Length (in) N/A N/A DWS Provided? N/A N/A N/A N/A **DWS Contrast?** Landing Width (in) N/A N/A Landing Slope (%) N/A N/A DWS Length (in) N/A N/A Landing X Slope (%) N/A N/A DWS Full Width? N/A N/A Landing Curb? (Y/N) N/A N/A DWS Offset (in) N/A N/A Shared Landing? N/A N/A **Gutter Ponding?** N/A N/A Gutter Slope (%) N/A N/A N/A Gutter Lip Ht (in) N/A Gutter X Slope (%) N/A N/A N/A Painted X Walk1? No Painted X Walk2? No To W X Walk 1 Direction X Walk 2 Direction To S X Walk 1 Width (in) N/A X Walk 2 Width (in) N/A X Walk 2 Slope (%) 1.7 1.4 X Walk 1 Slope (%) X Walk 1 X Slope (%) 0.3 X Walk 2 X Slope (%) 0.2 N/A N/A N/A Ramp inside XWalk1? Ramp inside XWalk2? N/A Road Slope (%) 0.8 Clear Space? N/A Road X Slope (%) 1.2 N/A Clear Space to XWalk (in) N/A

Remove & Replace Curb Ramp With
Two New Directional Ramps or
Equivalent.

PROW/ADA:
R304.5.3, R304.3.2
