# Access Compliance Report

## Public Rights-of-Way

### (Curb Ramps)

Intersection ID: N/A	Main Street: SPRINGWOOD_ESTATE_DR	Cross Street: BELVEDERE_CASTLE_DR	Location: NE
ADA ID: AF7C94D9CEFA	Ramp Type: BlendTrans1	Initial Pass/Fail: Fail	Overall Compliance: No
Severity Score: 12.5			
Codes/Mitigation Info/Possible Solution		Field Measurements/Component Compliance

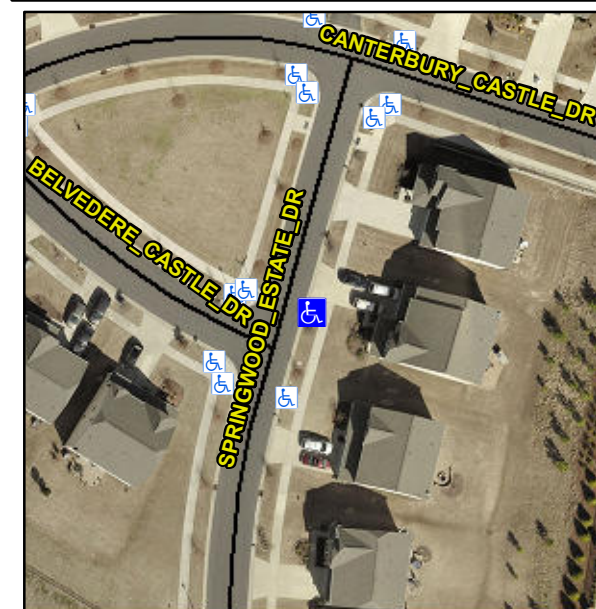
**Not Found, R304.5.3**

Compliance	Description	Data	Compliance	Description	Data
N/A	Ramp Length (in)	96.0	Yes	BlendTrans Slope (%)	2.7
Yes	Ramp Width (in)	48.0	No	BlendTrans XSlope (%)	5.6
N/A	Flare Type LT	N/A	N/A	Flare Type RT	N/A
N/A	Flare Slope LT (%)	N/A	N/A	Flare Slope RT (%)	N/A
N/A	Flare Traversable LT?	N/A	N/A	Flare Traversable RT?	N/A
N/A	Landing Length (in)	N/A	N/A	DWS Provided?	N/A
N/A	Landing Width (in)	N/A	N/A	DWS Contrast?	N/A
N/A	Landing Slope (%)	N/A	N/A	DWS Length (in)	N/A
N/A	Landing X Slope (%)	N/A	N/A	DWS Full Width?	N/A
N/A	Landing Curb? (Y/N)	N/A	N/A	DWS Offset (in)	N/A
N/A	Shared Landing?	N/A			
N/A	Gutter Ponding?	N/A	N/A	Gutter Slope (%)	N/A
N/A	Gutter Lip Ht (in)	N/A	N/A	Gutter X Slope (%)	N/A
N/A	Painted X Walk1?	No	N/A	Painted X Walk2?	N/A
	X Walk 1 Direction	To NW		X Walk 2 Direction	N/A
	X Walk 1 Width (in)	N/A		X Walk 2 Width (in)	N/A
	X Walk 1 Slope (%)	2.5		X Walk 2 Slope (%)	N/A
	X Walk 1 X Slope (%)	1.3		X Walk 2 X Slope (%)	N/A

N/A	Ramp inside XWalk1?	N/A	N/A	Ramp inside XWalk2?	N/A
	Road Slope (%)	1.3		Clear Space?	N/A
	Road X Slope (%)	2.5	N/A	Clear Space to XWalk (in)	N/A
N/A	Any Obstructions?	N/A	N/A	Storm Grate/Utility Hazard?	N/A
	Obstruction Type			Storm Grate/Utility Type	
		N/A			N/A
			Yes	Surface Condition? (G/P)	Good
			No	Curb Slope (%)	6.3

**Remove & Replace Curb Ramp With Two New Directional Ramps or Equivalent.**
