Access Compliance Report

Public Rights-of-Way

(Curb Ramps)

Intersection ID: 11185	Main Street: ALLEGHANY_ST	Cross Street: CARROWMORE_PL	Location: SE
ADA ID: AF87E56A82F9	Ramp Type: Perp	Initial Pass/Fail: Fail	Overall Compliance: No
Severity Score: 26.25			
Codes/Mitigation Info/Possible Solution		Field Measurements/Component Compliance

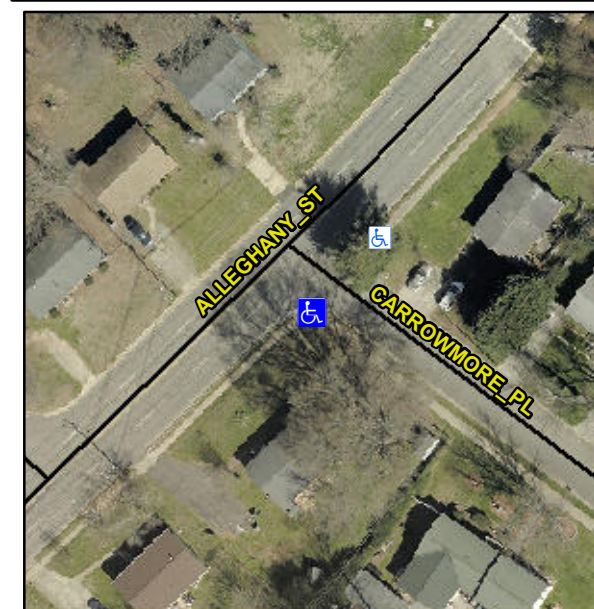
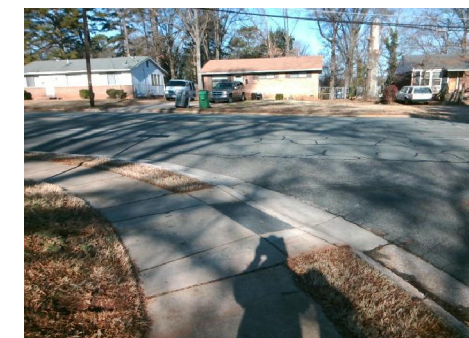
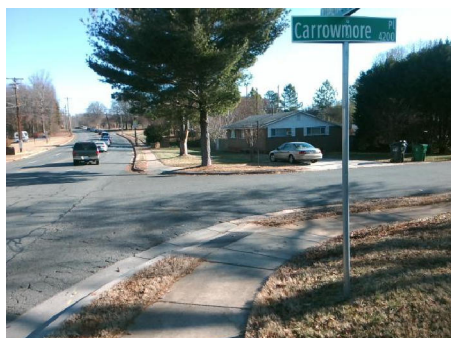
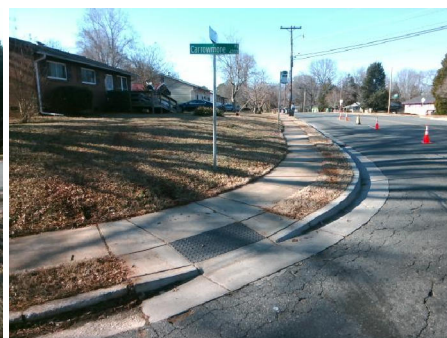
Not Found, R304.2.2, R304.5.3

Compliance	Description	Data	Compliance	Description	Data
N/A	Ramp Length (in)	24.0	No	Ramp Slope (%)	13.3
Yes	Ramp Width (in)	48.0	No	Ramp XSlope (%)	3.7
N/A	Flare Type LT	N/A	N/A	Flare Type RT	N/A
N/A	Flare Slope LT (%)	N/A	N/A	Flare Slope RT (%)	N/A
N/A	Flare Traversable LT?	N/A	N/A	Flare Traversable RT?	N/A
N/A	Landing Length (in)	N/A	N/A	DWS Provided?	N/A
N/A	Landing Width (in)	N/A	N/A	DWS Contrast?	N/A
N/A	Landing Slope (%)	N/A	N/A	DWS Length (in)	N/A
N/A	Landing X Slope (%)	N/A	N/A	DWS Full Width?	N/A
N/A	Landing Curb? (Y/N)	N/A	N/A	DWS Offset (in)	N/A
N/A	Shared Landing?	N/A			
N/A	Gutter Ponding?	N/A	N/A	Gutter Slope (%)	N/A
N/A	Gutter Lip Ht (in)	N/A	N/A	Gutter X Slope (%)	N/A
N/A	Painted X Walk1?	No	N/A	Painted X Walk2?	N/A
	X Walk 1 Direction	To NE		X Walk 2 Direction	N/A
N/A	X Walk 1 Width (in)	N/A	N/A	X Walk 2 Width (in)	N/A
	X Walk 1 Slope (%)	2.8		X Walk 2 Slope (%)	N/A
	X Walk 1 X Slope (%)	1.9		X Walk 2 X Slope (%)	N/A

N/A	Ramp inside XWalk1?	N/A	N/A	Ramp inside XWalk2?	N/A
	Road Slope (%)	N/A	N/A	Clear Space?	N/A
	Road X Slope (%)	N/A	N/A	Clear Space to XWalk (in)	N/A
N/A	Any Obstructions?	N/A	N/A	Storm Grate/Utility Hazard?	N/A
	Obstruction Type			Storm Grate/Utility Type	
		N/A			N/A
			Yes	Surface Condition? (G/P)	Good

Remove & Replace Entire Ramp.
