Access Compliance Report Public Rights-of-Way (Curb Ramps)

Intersection ID: 14281Main Street: E_KINGSTON_AVCross Street: LYNDHURST_AVLocation:NADA ID: AFA32C9190C8Ramp Type: Directional1Initial Pass/Fail: FailOverall Compliance: NoSeverity Score:25

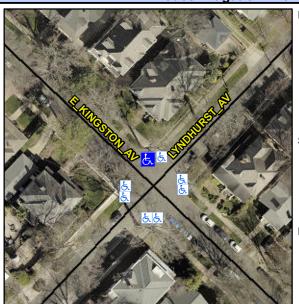
Field Measurements/Component Compliance								
Compli	ance Description	Data	Comp	liance Description	Data			
N/A	Ramp Length (in)	66.0	N/A	Grade Break?	N/A			
Yes	Ramp Width (in)	48.0	N/A	Grade Break Slope (%)	0.0			
No	Ramp Slope (%)	10.6	N/A	Grade Break XSlope (%)	0.0			
No	Ramp XSlope (%)	6.0						
N/A	Flare Type LT	N/A	N/A	Flare Type RT	N/A			
N/A	Flare Slope LT (%)	N/A	N/A	Flare Slope RT (%)	0.0			
N/A	Flare Traversable LT?	N/A	N/A	Flare Traversable RT?	N/A			
N/A	Landing Length (in)	0.0	N/A	DWS Provided?	N/A			
N/A	Landing Width (in)	0.0	N/A	DWS Contrast?	N/A			
N/A	Landing Slope (%)	0.0	N/A	DWS Length (in)	N/A			
N/A	Landing X Slope (%)	0.0	N/A	DWS Full Width?	N/A			
N/A	Landing Curb? (Y/N)	N/A	N/A	DWS Offset LT (in)	N/A			
N/A	Shared Landing?	N/A	N/A	DWS Offset RT (in)	N/A			
N/A	Gutter Ponding?	0.0	N/A	Gutter Slope (%)	N/A			
N/A	Gutter Lip Ht (in)	1.0	N/A	Gutter X Slope (%)	N/A			
N/A	Painted X Walk1?	No		Road Slope (%)	5.8

X Walk 1 Direction	To SW		Road X Slope (%)	1.8			
	X Walk 1 Width (in)	N/A		Clear Space?	N/A			
	X Walk 1 Slope (%)	5.8	N/A	Clear Space to XWalk (in)	N/A			
	X Walk 1 X Slope (%)	1.8	N/A	Storm Grate/Utility Hazard?	N/A			
N/A	Ramp inside XWalk1?	N/A		Storm Grate/Utility Type				
N/A	Any Obstructions?	N/A			N/A			
	Obstruction Type		Yes	Surface Condition? (G/P)	Good			
		N/A	N/A	Curb Slope (%)	0.5

Possible Solutions:	Con
Remove & Replace Entire Ramp.	N/A
·	Yes
	No
	No
	N/A
	N/A
Surveyor Notes:	N/A
N/A	N/A
	N/A
	N/A
	N/A
PROW/ADA:	N/A
R304.2.2, R304.5.3	N/A
	N/A
	N/A
	N/A
