## Access Compliance Report Public Rights-of-Way (Curb Ramps)

Intersection ID: 49933 Main Street: MARVIN\_RD Cross Street: WOBURN\_RD Location: SE

ADA ID: AFB08D977392 Ramp Type: Perp Initial Pass/Fail: Fail Overall Compliance: No Severity Score: 12.5

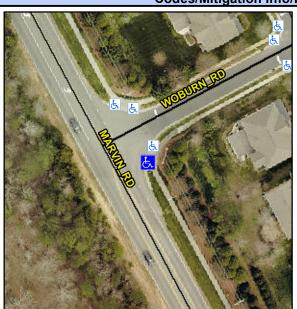
Not Found, R304.2.2

Field Measurements/Component Compilance					
Compliance Description		Data	Compliance Description		Data
N	/A Ramp Length (in)	59.0	No	Ramp Slope (%)	8.9
Y	es Ramp Width (in)	48.0	Yes	Ramp XSlope (%)	0.8
N	A Flare Type LT	N/A	N/A	Flare Type RT	N/A
N	/A Flare Slope LT (%)	N/A	N/A	Flare Slope RT (%)	N/A
N	/A Flare Traversable LT?	N/A	N/A	Flare Traversable RT?	N/A
N	/A Landing Length (in)	N/A	N/A	DWS Provided?	N/A
N	/A Landing Width (in)	N/A	N/A	DWS Contrast?	N/A
N	/A Landing Slope (%)	N/A	N/A	DWS Length (in)	N/A
N	/A Landing X Slope (%)	N/A	N/A	DWS Full Width?	N/A
N	/A Landing Curb? (Y/N)	N/A	N/A	DWS Offset (in)	N/A
N	A Shared Landing?	N/A			
N	A Gutter Ponding?	N/A	N/A	Gutter Slope (%)	N/A
N	A Gutter Lip Ht (in)	N/A	N/A	Gutter X Slope (%)	N/A
N	/A Painted X Walk1?	No	N/A	Painted X Walk2?	N/A
	X Walk 1 Direction	To W		X Walk 2 Direction	N/A

Remove & Replace Entire Ramp.
