Access Compliance Report

Public Rights-of-Way

(Curb Ramps)

| Intersection ID: 13120 | Main Street: PIEDMONT_ST | Cross Street: SUNNYSIDE_AV | Location: NW |

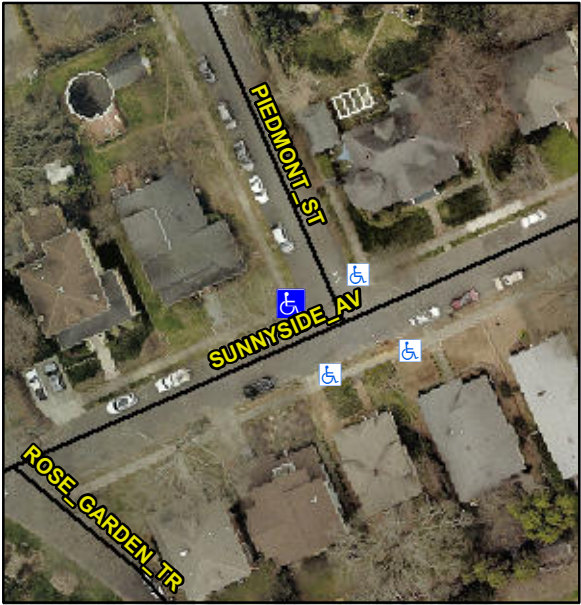
| ADA ID: AFBACA1C8648 | Ramp Type: PerpDiag | Initial Pass/Fail: Fail | Overall Compliance: No |
| | | | Severity Score: 26.25 |

| Codes/Mitigation Info/Possible Solution | | | Field Measurements/Component Compliance | | |
|---|---|---|---|---|---|
| | | | Yes | Ramp Width (in) | 59.0 |
| <p>Surveyor Notes:</p> <p>N/A</p> <p>PROW/ADA:</p> <p>Not Found, R304.2.2, R304.5.3</p> | | | N/A | Flare Type RT | N/A |
| | | | N/A | Gutter Lip Ht (in) | 1.0 |
| | | | Yes | Surface Condition? (G/P) | Good |

| Codes/Mitigation Info/Possible Solution | | | Field Measurements/Component Compliance | | |
|---|---|---|---|---|---|
| | Remove & Replace Curb Ramp With Two New Directional Ramps or Equivalent. | | N/A | Ramp Length (in) | 66.0 |
| Total Cost: | | \$ 3200.00 | | | |
