Access Compliance Report Public Rights-of-Way (Curb Ramps)

Intersection ID: 10019	N/A			Location:	N					
ADA ID: AFC47541B9	19463 Main Street: ALEXANDER_MARTIN_AV Cr 39BD Ramp Type: PerpDiag Ini				ail: Fail Overall	o Severity Score:	35			
Codes/Mitigation Info/Possible Solution					Field Measurements/Component Compliance					
Possible Solutions:				Compliance Description Data Compliance Description					Data	
Survey and		Remove & Replace Curb Ramp Wit Two New Directional Ramps or Equivalent.		N/A		76.0	Yes	Ramp Slope (%)	6.7	
BY COMPANY AND SALAND			•	N/A No	Ramp Length (in) Ramp Width (in)	28.0	Yes	Ramp XSlope (%)	0.7 1.8	
Kap Strate -	Minning of Contraction		71	N/A	,	28.0 N/A	N/A		1.0 N/A	
				N/A	Flare Type LT		N/A N/A	Flare Type RT		
and the second s					Flare Slope LT (%)	N/A		Flare Slope RT (%)	N/A	
me marked	יך די או			N/A	Flare Traversable LT?	N/A	N/A	Flare Traversable RT?	N/A	
Barnet Porting				N/A	Landing Length (in)	N/A	N/A	DWS Provided?	N/A	
ALEVAND		Surveyor Notes:		N/A	Landing Width (in)	N/A	N/A	DWS Contrast?	N/A

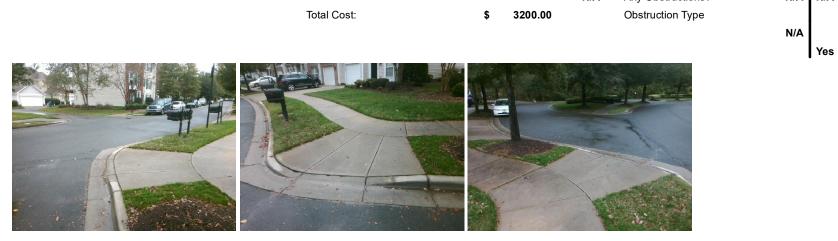
ALLEXANDER_MARTIN_AV	<mark>.5.</mark>	N/A		N/A	Landing Slope (%)	N/A	N/A	DWS Length (in)	N/A	
the second se	6			N/A	Landing X Slope (%)	N/A	N/A	DWS Full Width?	N/A	
				N/A	Landing Curb? (Y/N)	N/A	N/A	DWS Offset (in)	N/A	
	and mental 1			N/A	Shared Landing?	N/A				
	the second	PROW/ADA:		N/A	Gutter Ponding?	N/A	N/A	Gutter Slope (%)	N/A	
	381 6	Not Found, R304.5.1		N/A	Gutter Lip Ht (in)	N/A	N/A	Gutter X Slope (%)	N/A	
1 1 1	the second second			N/A	Painted X Walk1?	No	N/A	Painted X Walk2?	No	
					X Walk 1 Direction	To SW		X Walk 2 Direction	To SE

- track life			N/A	X Walk 1 Width (in)	N/A	N/A	X Walk 2 Width (in)	N/A	
Street 1 Name	ALEXANDER MARTIN AV				X Walk 1 Slope (%)	3.2		X Walk 2 Slope (%)	1.7	
Stop Condition-Street 2	None				X Walk 1 X Slope (%)	1.9		X Walk 2 X Slope (%)	0.2	
Street 2 Name	N/A			N/A	Ramp inside XWalk1?	N/A	N/A	Ramp inside XWalk2?	N/A	
Stop Condition-Street 1	None				Road Slope (%)	0.6	N/A	Clear Space?	N/A	
					Road X Slope (%)	2.6	N/A	Clear Space to XWalk (in)	N/A	
				N/A	Any Obstructions?	N/A	N/A	Storm Grate/Utility Hazard?	N/A	
		Total Cost: \$	3200.00		Obstruction Type			Storm Grate/Utility Type		
						N/A			N/A

es Surface Condition? (G/P)

Good
