# Access Compliance Report

## Public Rights-of-Way

### (Curb Ramps)

Intersection ID: 44686	Main Street: HARWOOD_HILLS_LN	Cross Street: GENTLE_STREAM_LN	Location: SE
ADA ID: AFEE2899A43D	Ramp Type: PerpDiag	Initial Pass/Fail: Fail	Overall Compliance: No
Severity Score: 22.5			
Codes/Mitigation Info/Possible Solution		Field Measurements/Component Compliance

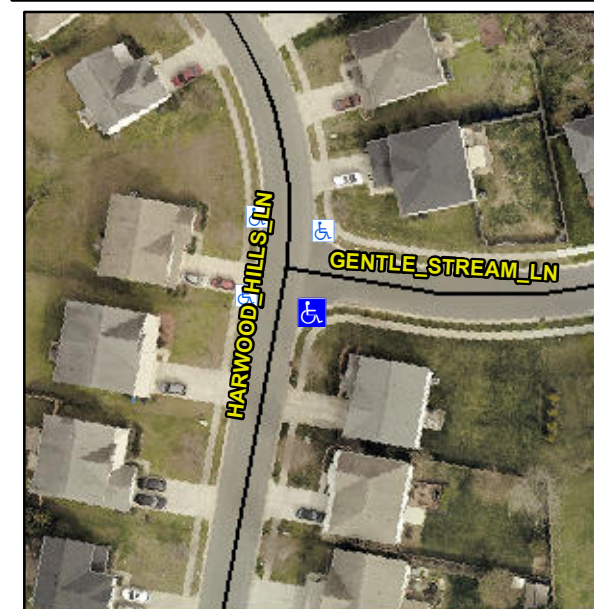
**Not Found, R304.5.1, R304.2.2, R304.5.3**

Compliance	Description	Data	Compliance	Description	Data
N/A	Ramp Length (in)	49.0	No	Ramp Slope (%)	8.4
No	Ramp Width (in)	47.5	No	Ramp XSlope (%)	3.1
N/A	Flare Type LT	N/A	N/A	Flare Type RT	N/A
N/A	Flare Slope LT (%)	N/A	N/A	Flare Slope RT (%)	N/A
N/A	Flare Traversable LT?	N/A	N/A	Flare Traversable RT?	N/A
N/A	Landing Length (in)	N/A	N/A	DWS Provided?	N/A
N/A	Landing Width (in)	N/A	N/A	DWS Contrast?	N/A
N/A	Landing Slope (%)	N/A	N/A	DWS Length (in)	N/A
N/A	Landing X Slope (%)	N/A	N/A	DWS Full Width?	N/A
N/A	Landing Curb? (Y/N)	N/A	N/A	DWS Offset (in)	N/A
N/A	Shared Landing?	N/A			
N/A	Gutter Ponding?	N/A	N/A	Gutter Slope (%)	N/A
N/A	Gutter Lip Ht (in)	N/A	N/A	Gutter X Slope (%)	N/A
N/A	Painted X Walk1?	No	N/A	Painted X Walk2?	No
	X Walk 1 Direction	To N		X Walk 2 Direction	To W
N/A	X Walk 1 Width (in)	N/A	N/A	X Walk 2 Width (in)	N/A
	X Walk 1 Slope (%)	2.3		X Walk 2 Slope (%)	6.4
	X Walk 1 X Slope (%)	2.9		X Walk 2 X Slope (%)	2.6

N/A	Ramp inside XWalk1?	N/A	N/A	Ramp inside XWalk2?	N/A
	Road Slope (%)	3.5	N/A	Clear Space?	N/A
	Road X Slope (%)	2.6	N/A	Clear Space to XWalk (in)	N/A
N/A	Any Obstructions?	N/A	N/A	Storm Grate/Utility Hazard?	N/A
	Obstruction Type			Storm Grate/Utility Type	
		N/A			N/A
			Yes	Surface Condition? (G/P)	Good

**Remove & Replace Curb Ramp With Two New Directional Ramps or Equivalent.**
