Access Compliance Report Public Rights-of-Way (Curb Ramps)

Intersection ID: 12054	Main Street: MCNINCH_ST	Cross Street: W_HILL_ST	Location: SW
ADA ID: AFF56105D445	Ramp Type: Perp	Initial Pass/Fail: Pass	Overall Compliance: No Severity Score: 0.25

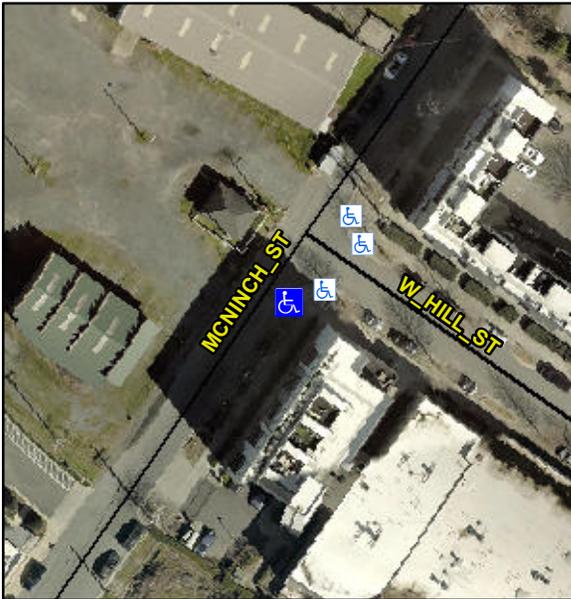
Not Found, R304.5.3

Compliance	Description	Data	Compliance	Description	Data
N/A	Ramp Length (in)	104.0	Yes	Ramp Slope (%)	5.8
Yes	Ramp Width (in)	48.0	No	Ramp XSlope (%)	4.0
N/A	Flare Type LT	Sloped	N/A	Flare Type RT	N/A
N/A	Flare Slope LT (%)	6.1	Yes	Flare Slope RT (%)	4.8
N/A	Flare Traversable LT?	Yes	N/A	Flare Traversable RT?	Yes
Yes	Landing Length (in)	72.0	Yes	DWS Provided?	Yes
Yes	Landing Width (in)	57.0	Yes	DWS Contrast?	Yes
Yes	Landing Slope (%)	1.6	Yes	DWS Length (in)	24.0
Yes	Landing X Slope (%)	1.7	Yes	DWS Full Width?	Yes
N/A	Landing Curb? (Y/N)	No	Yes	DWS Offset (in)	2.0
N/A	Shared Landing?	No			
Yes	Gutter Ponding?	No	Yes	Gutter Slope (%)	3.1
Yes	Gutter Lip Ht (in)	0.0	Yes	Gutter X Slope (%)	1.8
N/A	Painted X Walk1?	No	N/A	Painted X Walk2?	N/A
	X Walk 1 Direction	To N		X Walk 2 Direction	N/A
N/A	X Walk 1 Width (in)	N/A	N/A	X Walk 2 Width (in)	N/A
	X Walk 1 Slope (%)	4.0		X Walk 2 Slope (%)	N/A
	X Walk 1 X Slope (%)	1.9		X Walk 2 X Slope (%)	N/A

N/A	Ramp inside XWalk1?	N/A	N/A	Ramp inside XWalk2?	N/A
	Road Slope (%)	N/A	N/A	Clear Space?	Yes
	Road X Slope (%)	N/A	N/A	Clear Space to XWalk (in)	N/A
Yes	Any Obstructions?	No	Yes	Storm Grate/Utility Hazard?	No
	Obstruction Type			Storm Grate/Utility Type	
			N/A		N/A
			Yes	Surface Condition? (G/P)	Good

Possible Solutions:

Remove & Replace Entire Ramp.

Total Cost: \$ 1850.00
