## **Access Compliance Report Public Rights-of-Way** (Curb Ramps)

Intersection ID: 43649 Main Street: FERGUSON FOREST DR Cross Street: SWANN\_BRANCH\_DR Location: SE **ADA ID: AFF87FEE05CB** Ramp Type: Perp Initial Pass/Fail: Fail **Overall Compliance: No Severity Score:** 8.75

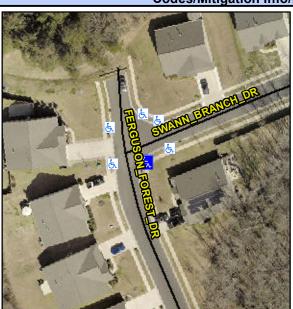
Field Measurements/Component Compliance										
Comp	liance Description	Data	Complia	nce Description	Data					
N/A	Ramp Length (in)	48.0	Yes	Ramp Slope (%)	7.4					
No	Ramp Width (in)	47.0	Yes	Yes Ramp XSlope (%)						
N/A	Flare Type LT	N/A	N/A	N/A Flare Type RT						
N/A	Flare Slope LT (%)	N/A	N/A Flare Slope RT (%)		N/A					
N/A	Flare Traversable LT?	N/A	N/A	N/A Flare Traversable RT?						
N/A	Landing Length (in)	N/A	N/A	DWS Provided?	N/A					
N/A	Landing Width (in)	N/A	N/A	DWS Contrast?	N/A					
N/A	Landing Slope (%)	N/A	N/A	DWS Length (in)	N/A					
N/A	Landing X Slope (%)	N/A	N/A	DWS Full Width?	N/A					
N/A	Landing Curb? (Y/N)	N/A	N/A	DWS Offset (in)	N/A					
N/A	Shared Landing?	N/A								
N/A	Gutter Ponding?	N/A	N/A	Gutter Slope (%)	N/A					
N/A	Gutter Lip Ht (in)	N/A	N/A	Gutter X Slope (%)	N/A					
N/A	Painted X Walk1?	No	N/A	Painted X Walk2?	N/A					
	X Walk 1 Direction	To W		X Walk 2 Direction	N/A

N/A	X Walk 1 Width (in)	N/A	N/A	X Walk 2 Width (in)	N/A					
	X Walk 1 Slope (%)	1.7		X Walk 2 Slope (%)	N/A					
	X Walk 1 X Slope (%)	0.4		X Walk 2 X Slope (%)	N/A					
N/A	Ramp inside XWalk1?	N/A	N/A	Ramp inside XWalk2?	N/A					
	Road Slope (%)	N/A	N/A	Clear Space?	N/A					
	Road X Slope (%)	N/A	N/A	Clear Space to XWalk (in)	N/A					
N/A	Any Obstructions?	N/A	N/A	Storm Grate/Utility Hazard?	N/A					
	Obstruction Type			Storm Grate/Utility Type						
		N/A			N/A					
			Yes	Surface Condition? (G/P)	Good

b	Possible Solutions:
The state of the s	Remove & Replace Entire Ramp.
The second secon	Surveyor Notes: N/A
The second secon	PROW/ADA: R304.5.1
