Intersection ID: 7540	Main Street: BROOKSHIRE_BV	Cross Street: CAROTHERS_ST	Location:	N/A
ADA ID: B002ADDCF585	Ramp Type: Perp	Initial Pass/Fail: Fail	Overall Compliance: No	Severity Score: 33.75

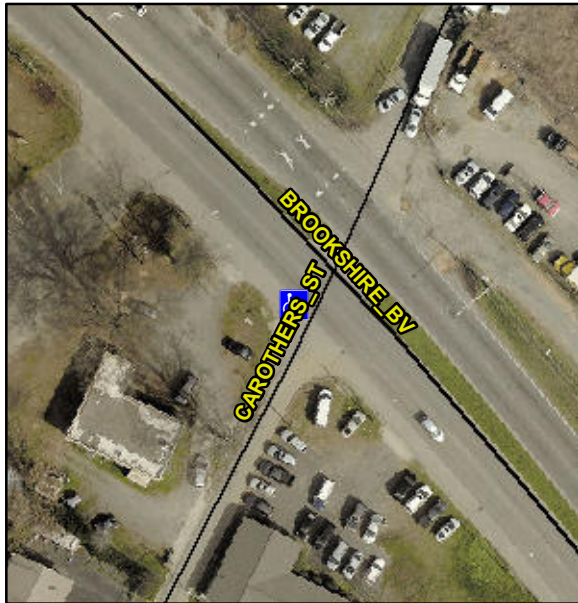
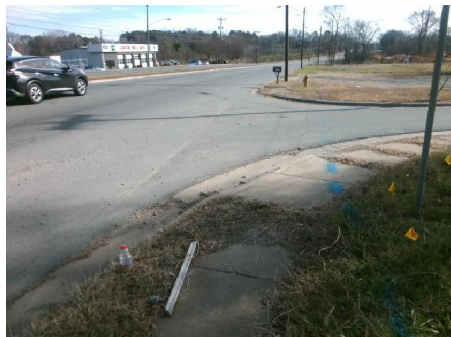
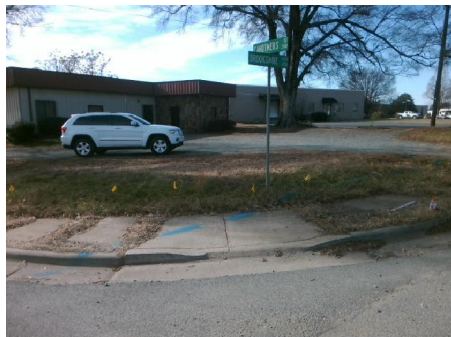
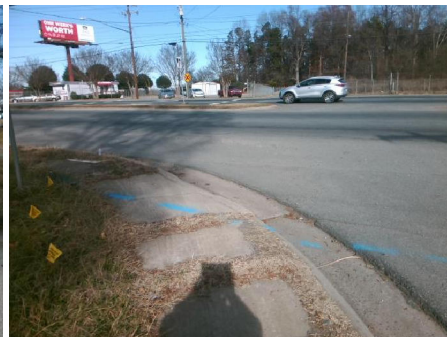
**Not Found, R304.5.1, R304.2.2,
R304.5.3**

Compliance	Description	Data	Compliance	Description	Data
N/A	Ramp Length (in)	57.0	No	Ramp Slope (%)	9.0
No	Ramp Width (in)	45.0	No	Ramp XSlope (%)	6.1
N/A	Flare Type LT	N/A	N/A	Flare Type RT	N/A
N/A	Flare Slope LT (%)	N/A	N/A	Flare Slope RT (%)	N/A
N/A	Flare Traversable LT?	N/A	N/A	Flare Traversable RT?	N/A
N/A	Landing Length (in)	N/A	N/A	DWS Provided?	N/A
N/A	Landing Width (in)	N/A	N/A	DWS Contrast?	N/A
N/A	Landing Slope (%)	N/A	N/A	DWS Length (in)	N/A
N/A	Landing X Slope (%)	N/A	N/A	DWS Full Width?	N/A
N/A	Landing Curb? (Y/N)	N/A	N/A	DWS Offset (in)	N/A
N/A	Shared Landing?	N/A			
N/A	Gutter Ponding?	N/A	N/A	Gutter Slope (%)	N/A
N/A	Gutter Lip Ht (in)	3.0	N/A	Gutter X Slope (%)	N/A
N/A	Painted X Walk1?	No	N/A	Painted X Walk2?	N/A
	X Walk 1 Direction	To S		X Walk 2 Direction	N/A
N/A	X Walk 1 Width (in)	N/A	N/A	X Walk 2 Width (in)	N/A
	X Walk 1 Slope (%)	2.7		X Walk 2 Slope (%)	N/A
	X Walk 1 X Slope (%)	3.4		X Walk 2 X Slope (%)	N/A

N/A	Ramp inside XWalk1?	N/A	N/A	Ramp inside XWalk2?	N/A
	Road Slope (%)	3.4	N/A	Clear Space?	N/A
	Road X Slope (%)	2.7	N/A	Clear Space to XWalk (in)	N/A
N/A	Any Obstructions?	N/A	N/A	Storm Grate/Utility Hazard?	N/A
	Obstruction Type			Storm Grate/Utility Type	
		N/A			N/A
			Yes	Surface Condition? (G/P)	Good

Remove & Replace Entire Ramp.
