## **Access Compliance Report Public Rights-of-Way** (Curb Ramps)

Intersection ID: 20942 Main Street: CORONATION BV **Cross Street: CROWN CENTRE DR** Location: SW **Overall Compliance: No** ADA ID: B01588667C73 Ramp Type: PerpDiag Initial Pass/Fail: Fail **Severity Score:** 37.5

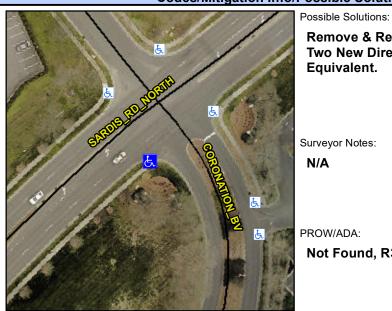
Not Found, R304.2.2, R304.5.3

N/A	Ramp Length (in)	52.0	No	Ramp Slope (%)	14.9
Yes	Ramp Width (in)	48.0	No	Ramp XSlope (%)	5.8
N/A	Flare Type LT	N/A	N/A	Flare Type RT	N/A
N/A	Flare Slope LT (%)	N/A	N/A	Flare Slope RT (%)	N/A
N/A	Flare Traversable LT?	N/A	N/A	Flare Traversable RT?	N/A
N/A	Landing Length (in)	N/A	N/A	DWS Provided?	N/A
N/A	Landing Width (in)	N/A	N/A	DWS Contrast?	N/A
N/A	Landing Slope (%)	N/A	N/A	DWS Length (in)	N/A
N/A	Landing X Slope (%)	N/A	N/A	DWS Full Width?	N/A
N/A	Landing Curb? (Y/N)	N/A	N/A	DWS Offset (in)	N/A
N/A	Shared Landing?	N/A			
N/A	Gutter Ponding?	N/A	N/A	Gutter Slope (%)	N/A
N/A	Gutter Lip Ht (in)	N/A	N/A	Gutter X Slope (%)	N/A
N/A	Painted X Walk1?	No	N/A	Painted X Walk2?	No
	X Walk 1 Direction	To NE		X Walk 2 Direction	To N
N/A	X Walk 1 Width (in)	N/A	N/A	X Walk 2 Width (in)	N/A
	X Walk 1 Slope (%)	3.9		X Walk 2 Slope (%)	5.1
	X Walk 1 X Slope (%)	4.1		X Walk 2 X Slope (%)	4.6
N/A	Ramp inside XWalk1?	N/A	N/A	Ramp inside XWalk2?	N/A

Road Slope (%)	1.8	N/A	Clear Space?	N/A
	Road X Slope (%)	5.2	N/A	Clear Space to XWalk (in)	N/A
N/A	Any Obstructions?	N/A	N/A	Storm Grate/Utility Hazard?	N/A
	Obstruction Type			Storm Grate/Utility Type	
		N/A			N/A
NAT C			Yes	Surface Condition? (G/P)	Good

Remove & Replace Curb Ramp With Two New Directional Ramps or Equivalent.
