Access Compliance Report

Public Rights-of-Way

(Curb Ramps)

| Intersection ID: 53502 | Main Street: WRIGHT_HILL_RD | Cross Street: BERKELEY_PLACE_DR | Location: NW |

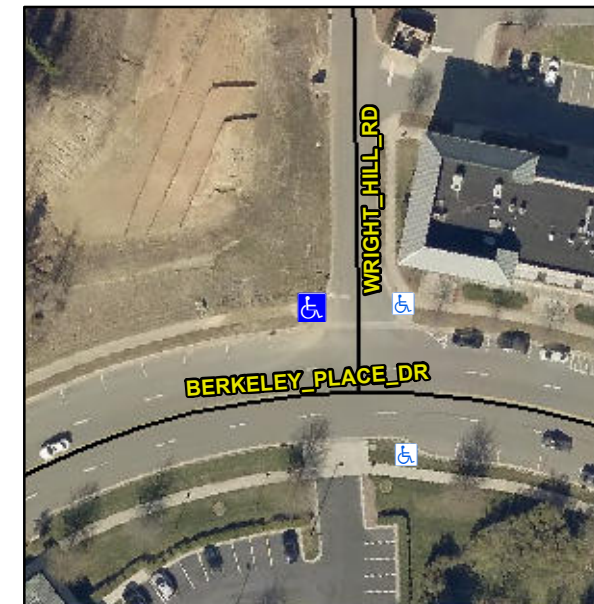
| ADA ID: B019DD9D1AD1 | Ramp Type: Perp | Initial Pass/Fail: Fail | Overall Compliance: No |
| Severity Score: 26.25 | | | |

R304.2.2, R304.5.3

| Compliance | Description | Data | Compliance | Description | Data |
|---|---|---|---|---|---|
| N/A | Ramp Length (in) | 72.5 | No | Ramp Slope (%) | 20.0 |
| Yes | Ramp Width (in) | 72.5 | No | Ramp XSlope (%) | 4.3 |
| N/A | Gutter Ponding? | Yes | N/A | Gutter Slope (%) | N/A |

Remove & Replace Entire Ramp.
