Access Compliance Report

Public Rights-of-Way

(Curb Ramps)

| Intersection ID: 10020989 | Main Street: BERE_ISLAND_DR | Cross Street: N/A | Location: SE |

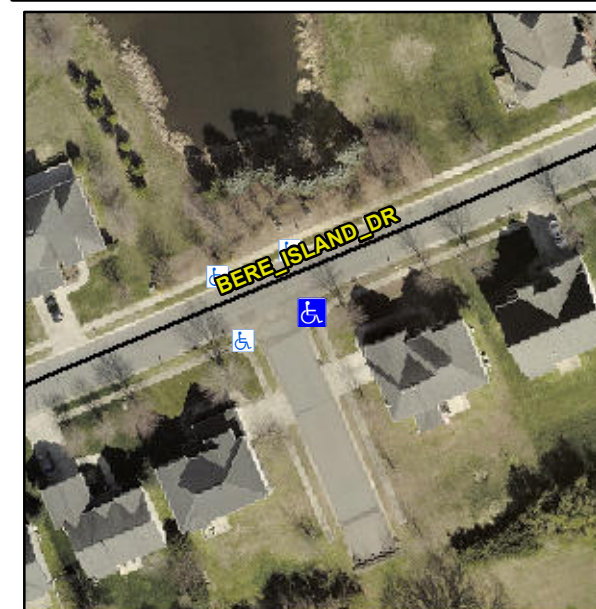
| ADA ID: B027DB44D97A | Ramp Type: PerpDiag | Initial Pass/Fail: Fail | Overall Compliance: No |
| Severity Score: 22.5 | | | |

Not Found, R304.5.1, R304.2.2, R304.5.3

| Compliance | Description | Data | Compliance | Description | Data |
|---|---|---|---|---|---|
| N/A | Ramp Length (in) | 45.5 | No | Ramp Slope (%) | 8.5 |
| No | Ramp Width (in) | 46.5 | No | Ramp XSlope (%) | 4.6 |

Remove & Replace Curb Ramp With Two New Directional Ramps or Equivalent.
